# Inspection Results & Trends

**Relating to ARCSOPT Technical Guidelines**

ARCSOPT In Person Meeting – 01 November 2023

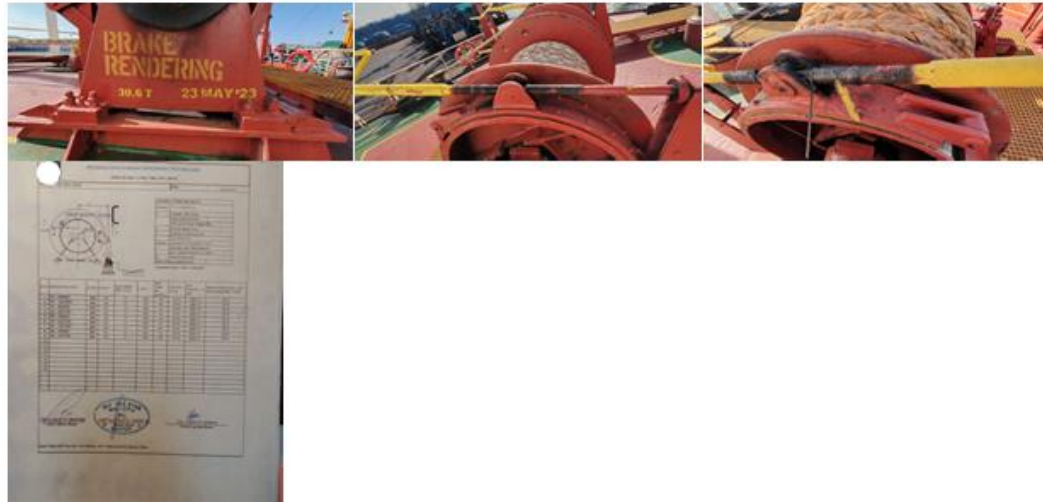
6.11 Do all mooring winches have a valid test for brake holding capacity and the mooring winches being correctly set?\*

**Brake render tested record on 23 May 2023, but no latest test report/certificate provided. And also brake spindle at the rendering position was not marked.**  
Rectified during inspection:NO

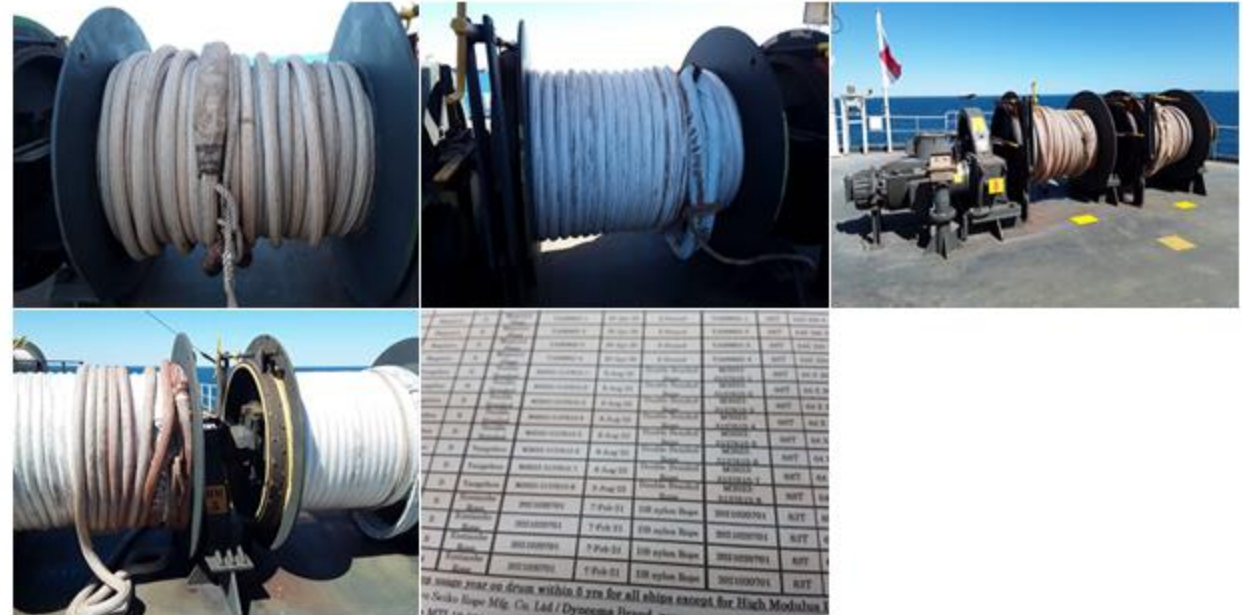
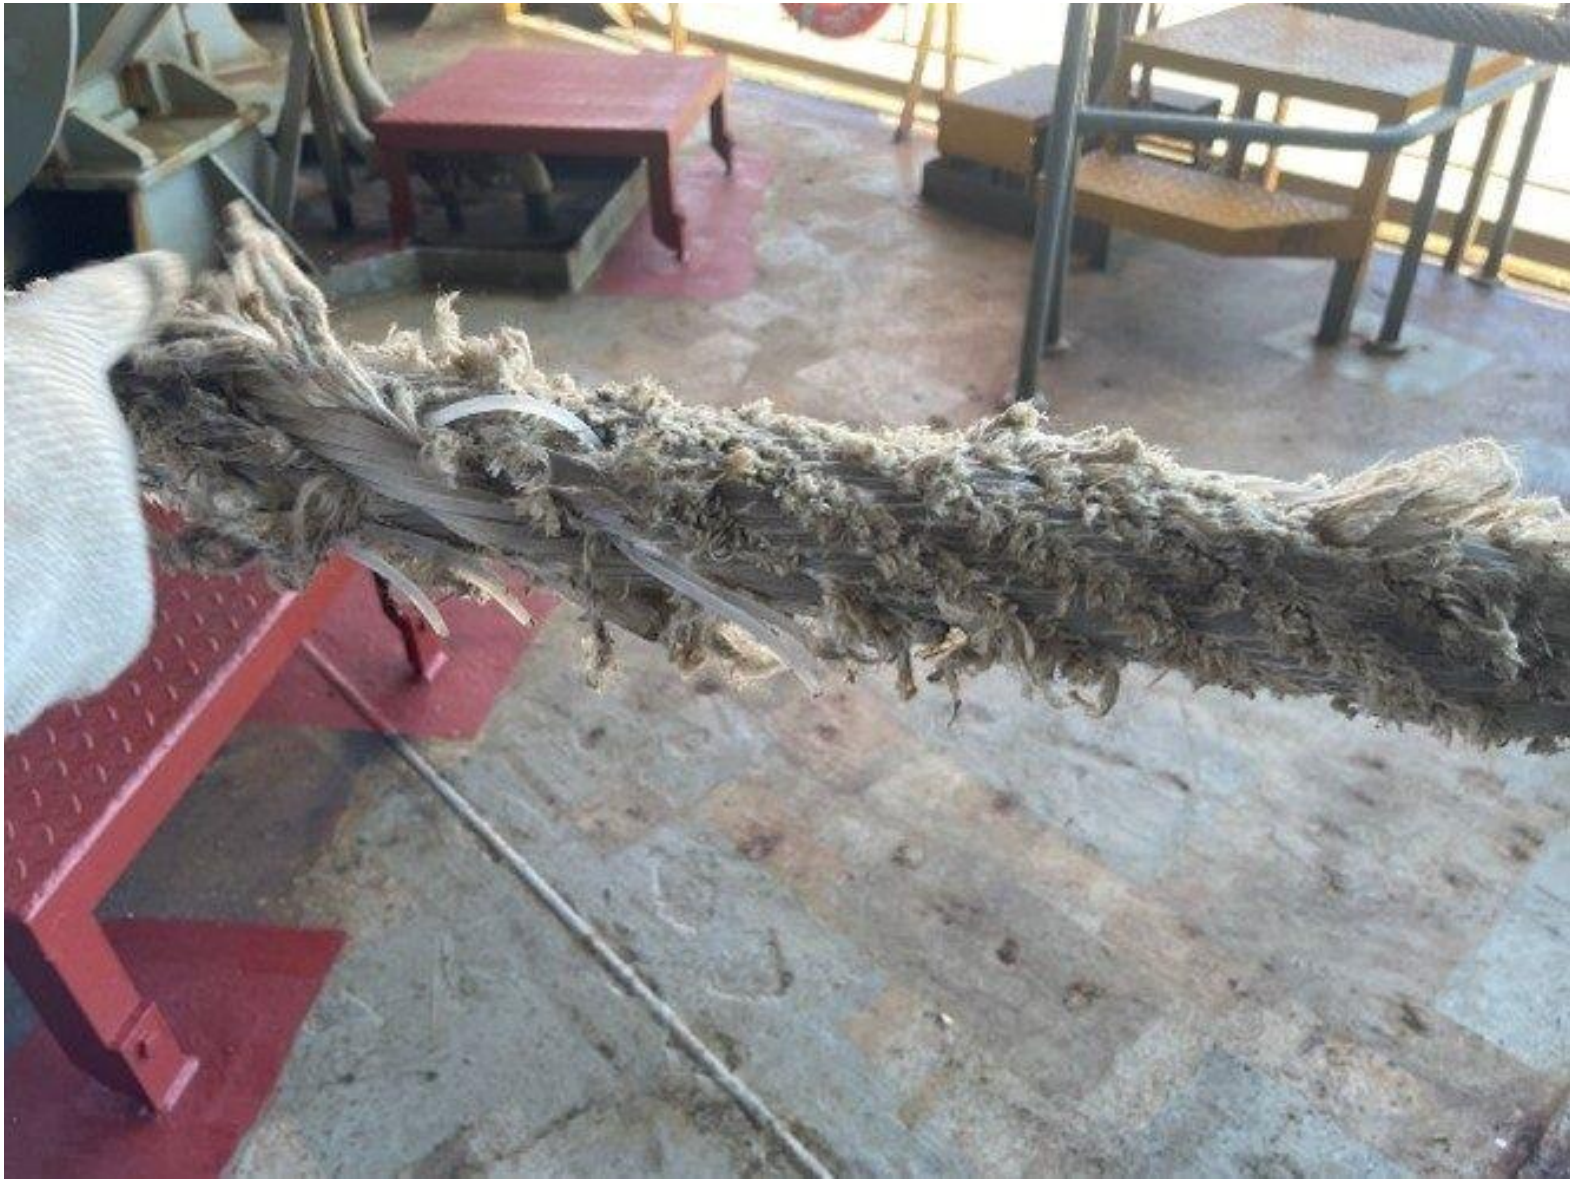
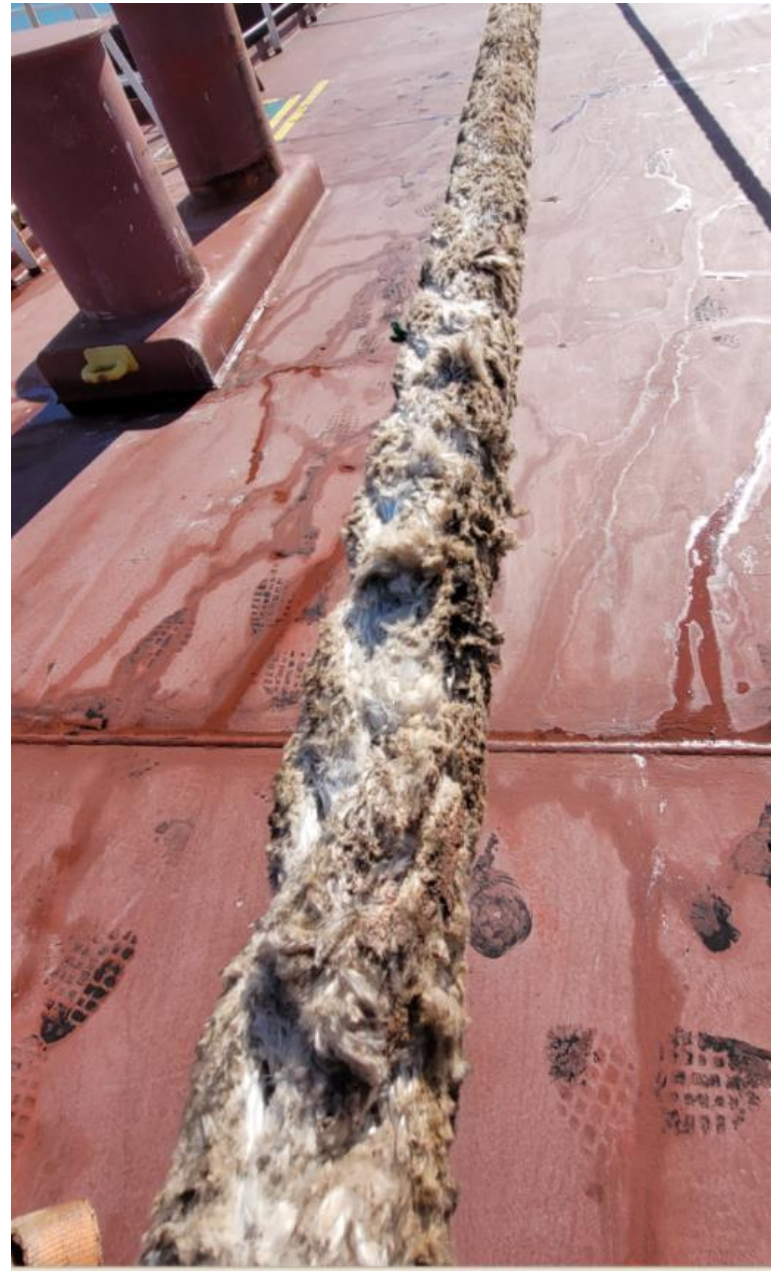
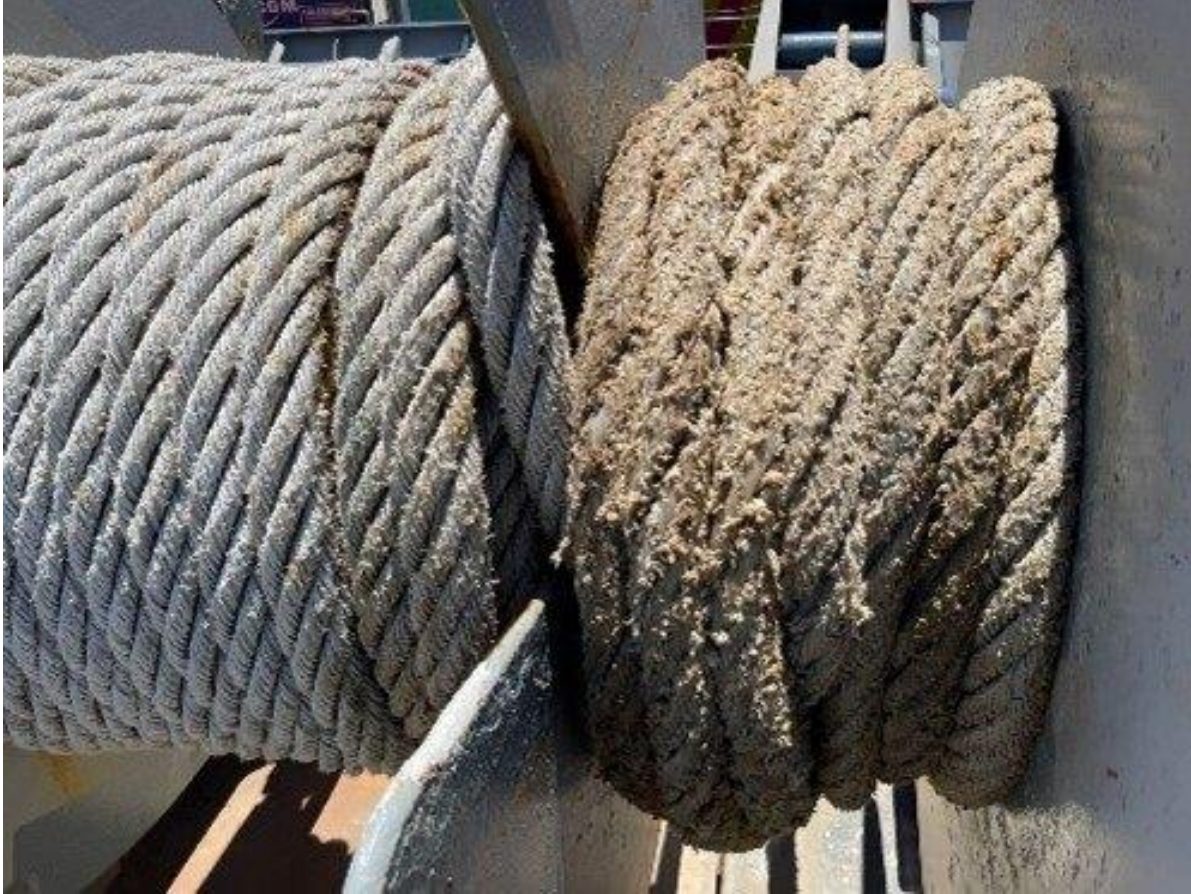
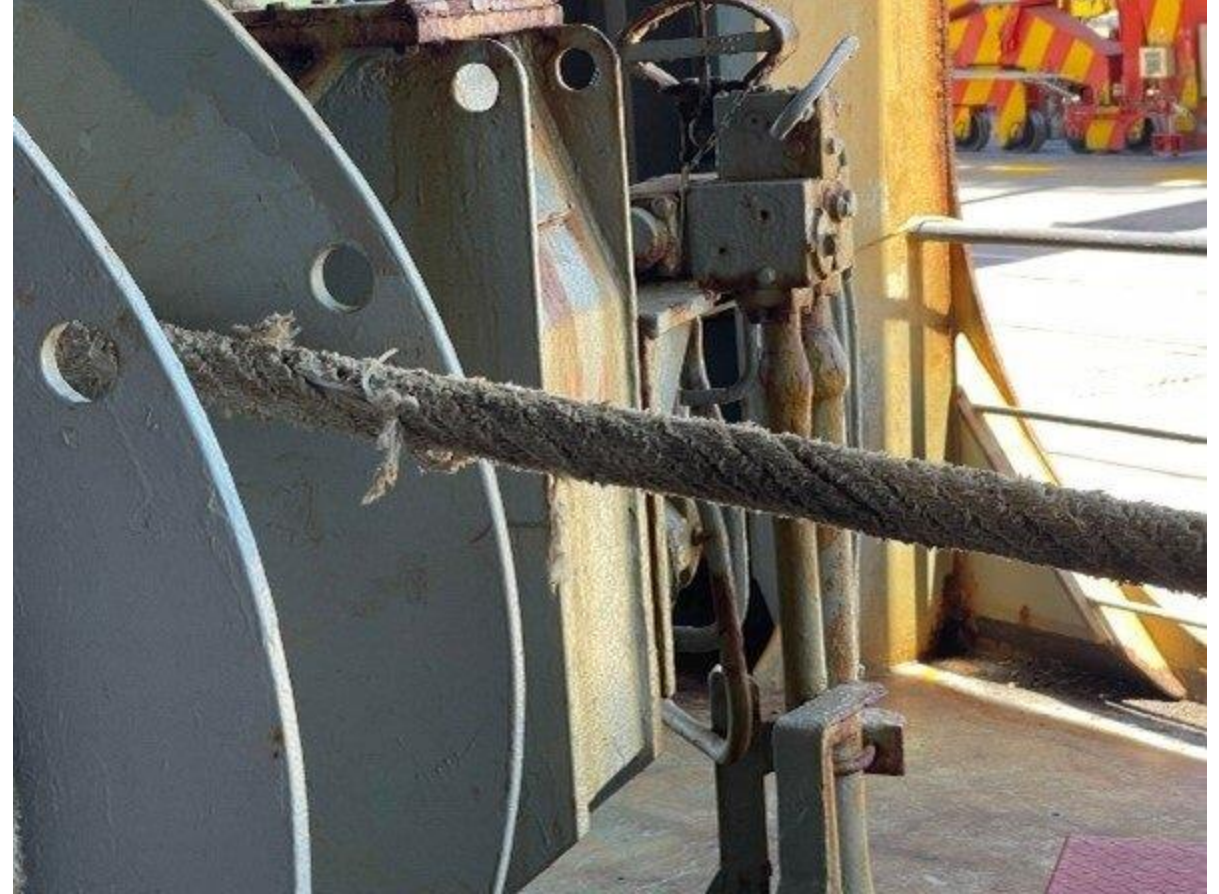
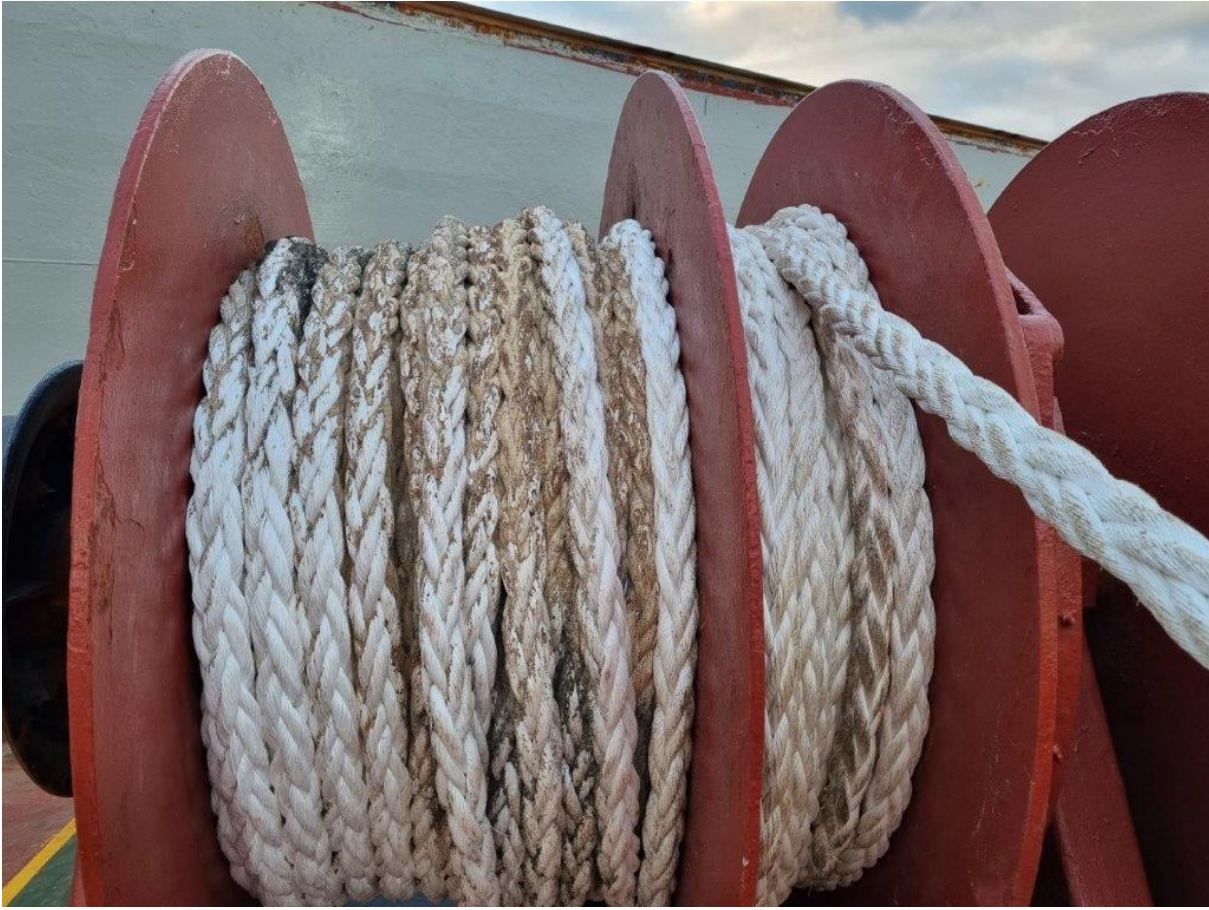
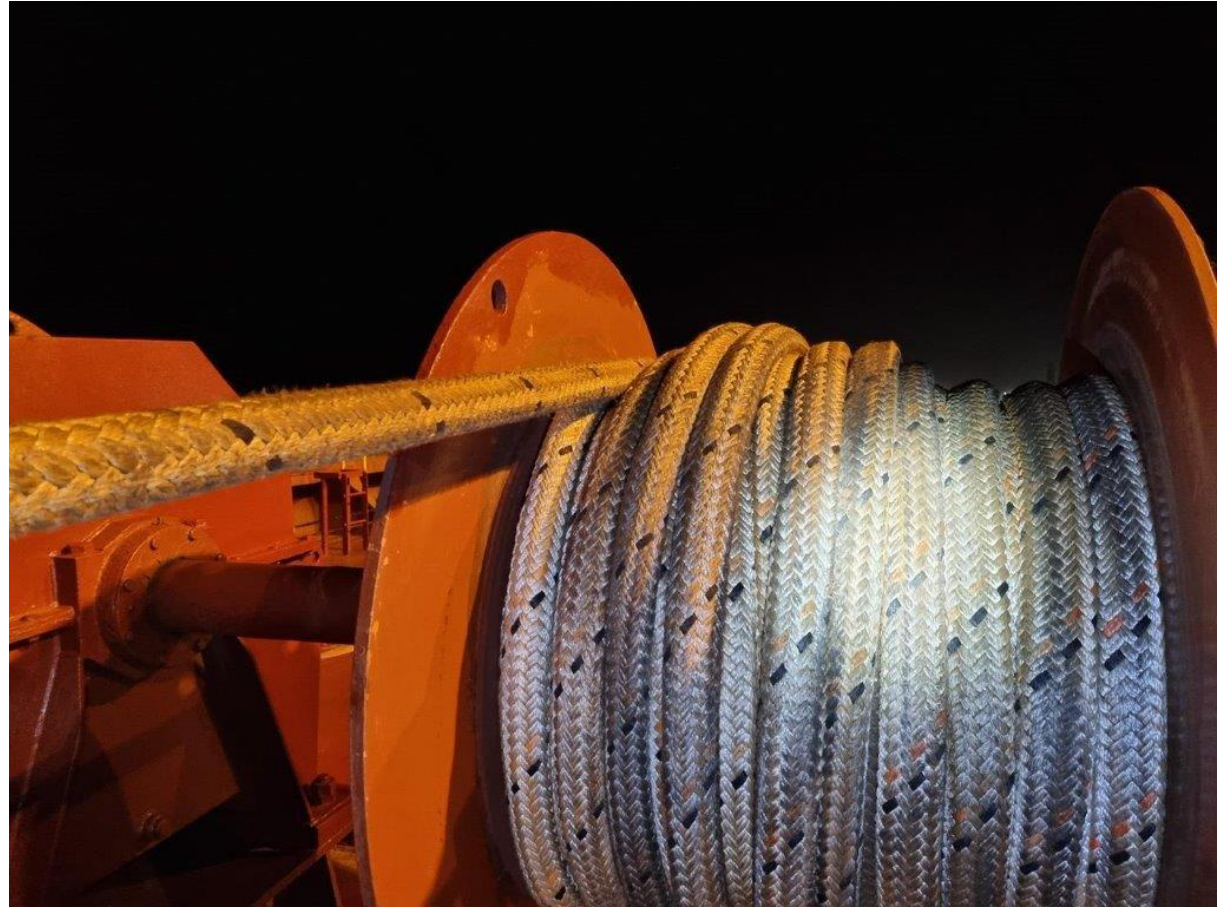
6.01 Are the mooring lines in good condition and regularly inspected?\*

**Observed that of the 16 installed lines, 12 were polypropylene, and 4 were nylon (the 4 stern lines).**

*While all lines were observed in acceptable condition, mixed mooring line material types are not recommended due to their very different elasticity and characteristics. Recommend vessel consider replacement or redistribution.*

*Double braided lines*

*In acceptable visual conditions*

*88 mt MBL. All less than 18 months in use. Some newly installed.*

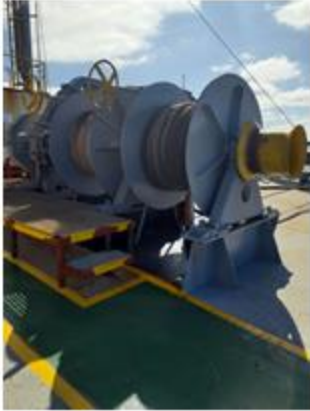
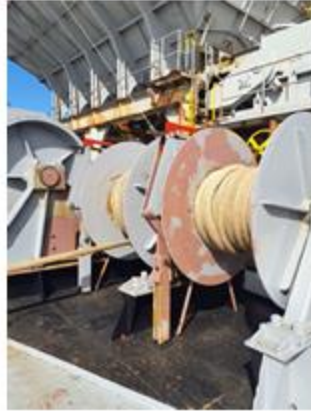
6.07 Is all mooring equipment marked with SWL?  
Guidance: Each item of mooring equipment should be marked with its SWL. The amount should be weld in bead in tonnes or kilo-Newtons (kN).  
**None of the Mooring equipment had SWL markings.**  
Rectified during inspection:NO

**Comments:**  
The Chief Officer communicated that maintenance is currently in progress and markings will be applied upon the completion of maintenance.

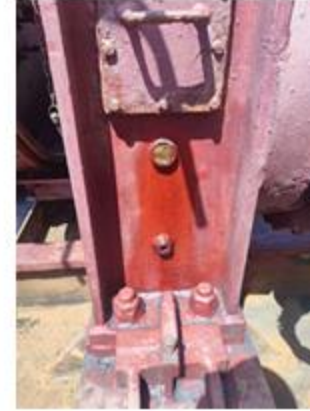
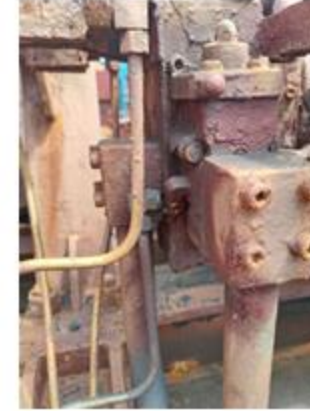
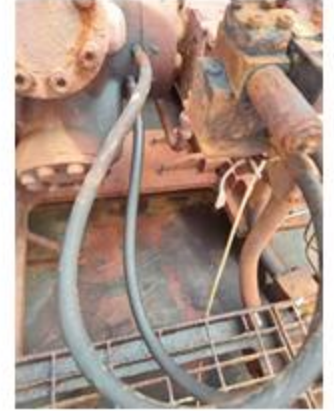
6.12 Are hydraulic mooring winch motors, pumps, controls and pipelines free of leaks?

**Some leakage found on the mooring winch:**

1. Sightglass leakage on the poop deck (s)
2. Tube leakage on the No.8 cross deck
3. Hose leakage on the NO.1 cross deck

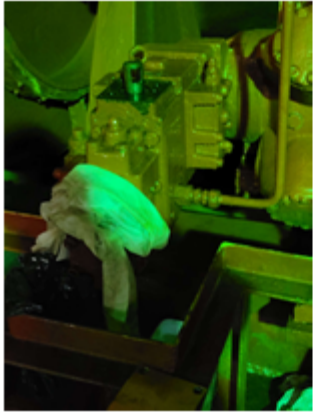
6.05 Are the mooring and anchor winches in good condition?

**The control lever box of aft mooring winch port side was defective.**  
Rectified during inspection:NO

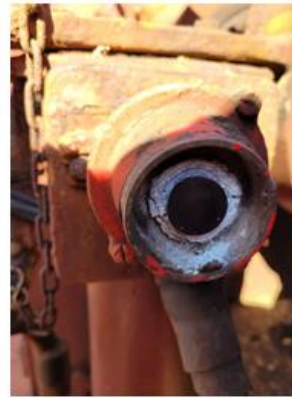
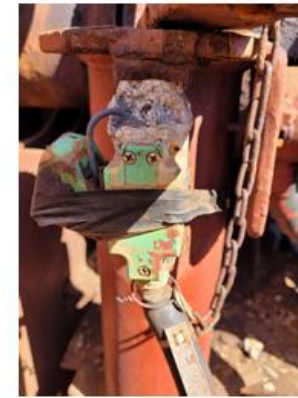
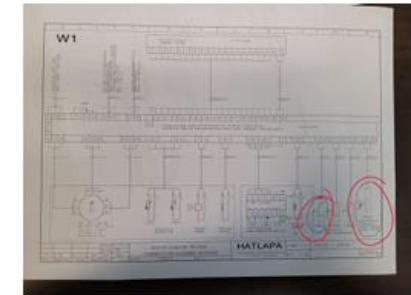
6.05 Are the mooring and anchor winches in good condition?

**1) Turn push buttons for both port and stbd anchor winches were heavily corroded and inoperable. Rectified during inspection by replacing them with new push buttons.**

**2) Limit switch cable lifters for both port and stbd anchor winches were damaged, not operational. (not rectified)**

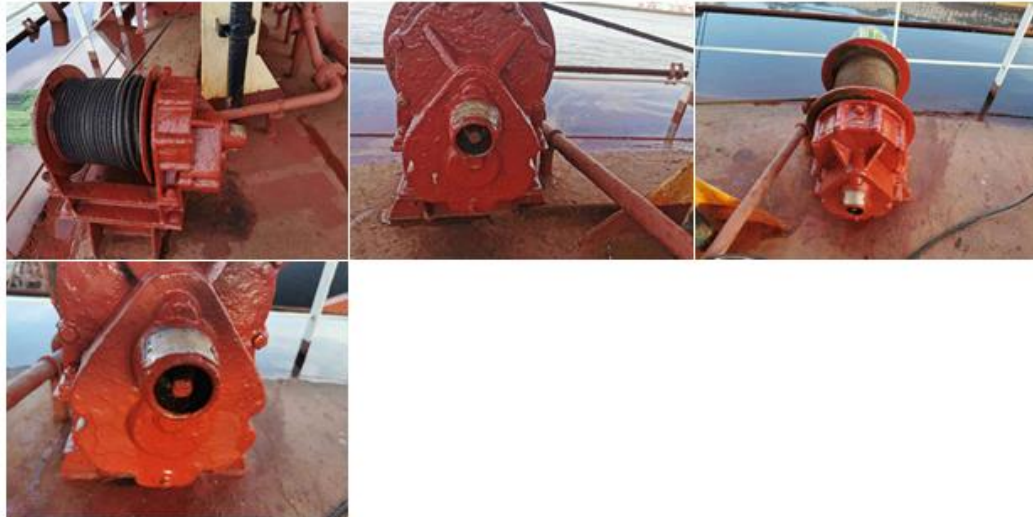
- 1.03 Is the accommodation ladder in good condition and correctly deployed?  
*Guidance: The accommodation ladder angle should be less than 55 degrees. The accommodation ladder should be clearly marked showing restrictions on safe operations, maximum and minimum design angles, SWL and maximum persons. Inspect for corrosion and cracks that may appear in the areas of dis-similar metals (aluminium/steel)The safety net and platform stanchions must be rigged. Secondary support rigging should be described in the SMS.*  
**Emergency operation handle for P&S accommodation ladder winch missed.**  
Rectified during inspection:NO

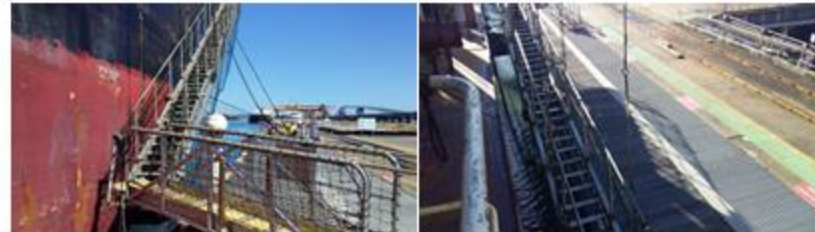
- 1.03 Is the accommodation ladder in good condition and correctly deployed?  
*Guidance: The accommodation ladder angle should be less than 55 degrees. The accommodation ladder should be clearly marked showing restrictions on safe operations, maximum and minimum design angles, SWL and maximum persons. Inspect for corrosion and cracks that may appear in the areas of dis-similar metals (aluminium/steel)The safety net and platform stanchions must be rigged. Secondary support rigging should be described in the SMS.*  
**Accommodation ladder deployed, but supported outboard end by bunker crane, which is not rated for the gangway load.**  
Rectified during inspection:NO  
**Comments:**  
*Rigged outboard end to help support outboard end gangway, but greater than capacity of bunker davit. AMSA noted and request for removal.*

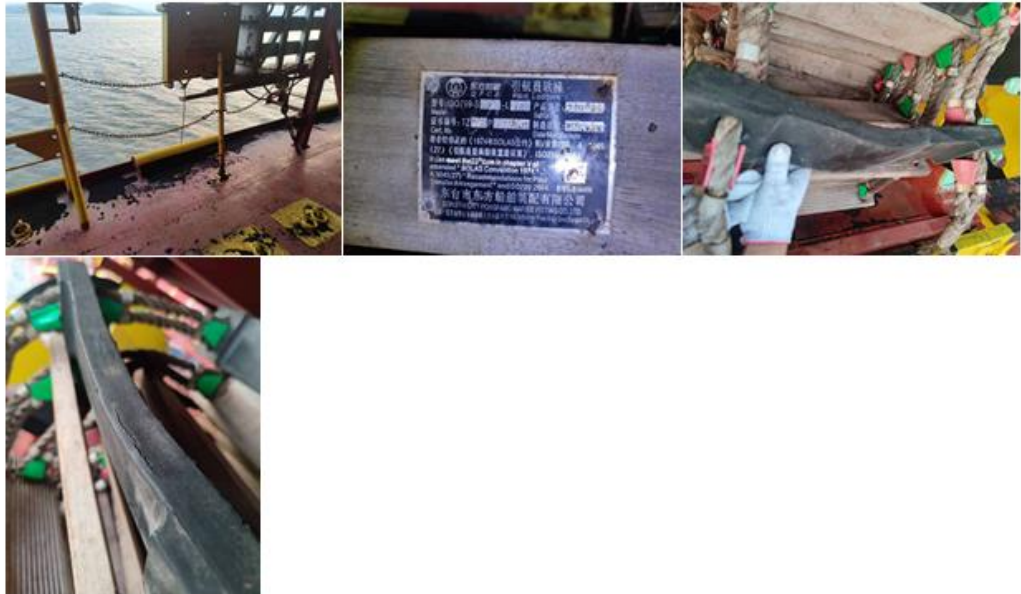
## 1.04 Are pilot boarding and access arrangements satisfactory?\*

1. Two chains / handrail for pilot boarding and access area missing (p).
2. Pilot ladder (P) certificate date on 30 Jun.2020 and was more than 30 months and two steps were deformed and cracked. Recommended replace.

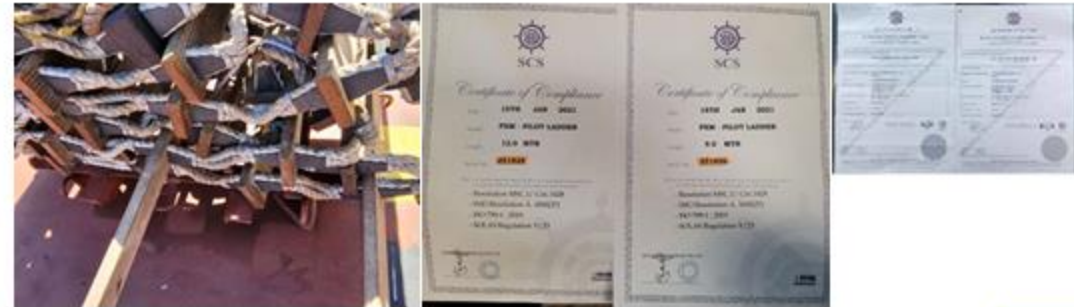
## 1.04 Are pilot boarding and access arrangements satisfactory?\*

**Pilot ladders appeared in acceptable condition, however they had been in use for more than 30 months. Their certificates dated 15 Jan 2021.**  
Rectified during inspection:NO

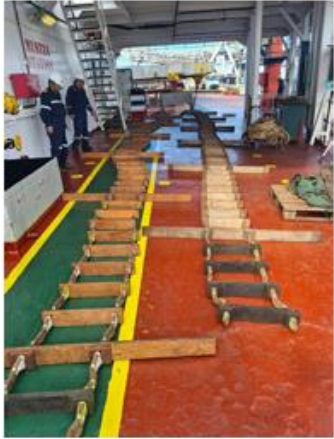
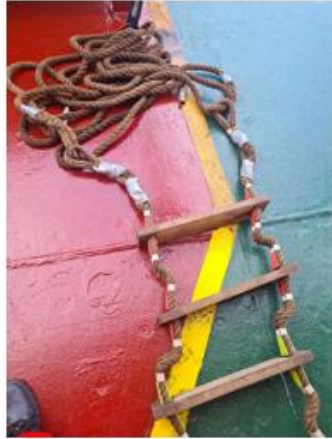
1.04 Are pilot boarding and access arrangements satisfactory?\*

**One pilot ladder has a number of loose spreaders and a damaged bottom rubber step. Splices on securing tails are taped up. Recommendation is to retire and replace.**

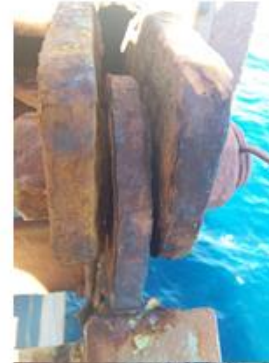
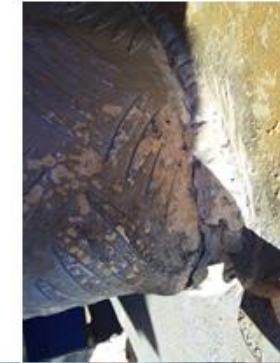
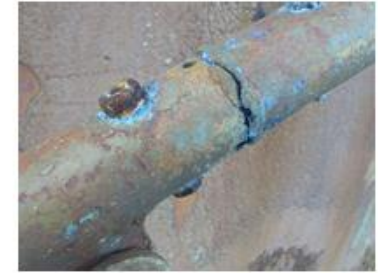
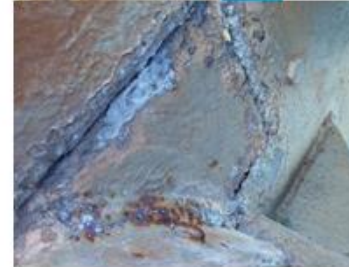
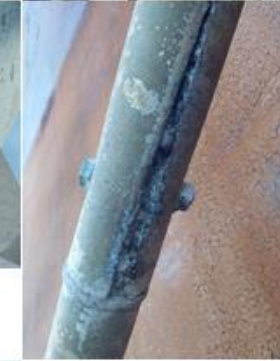
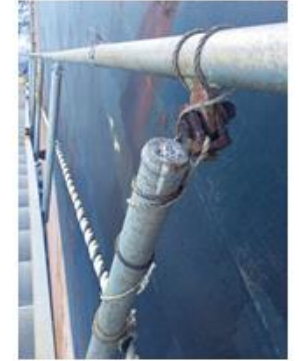
1.04 Are pilot boarding and access arrangements satisfactory?\*

**stb pilot boarding gangway is suffering alloy cracks in handrails, steps and side fitting in way of rollers. cracks and splits also noted under hand rails or at hinge fixture.**

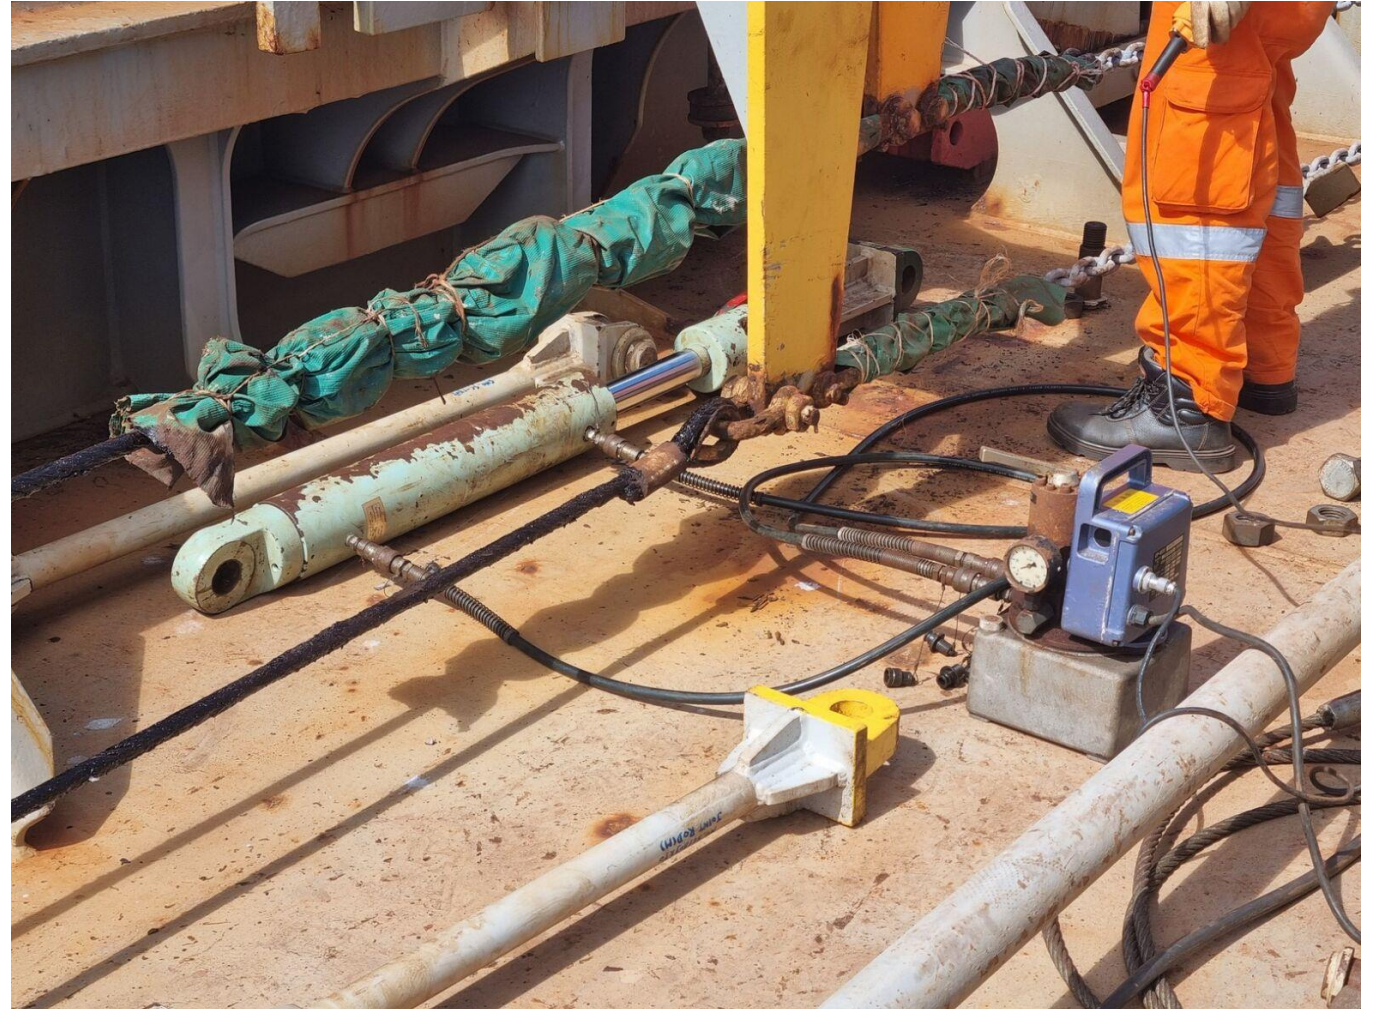
# Emergency Hatch Operation

- Example - Vessel in Port Hedland last year
- Electric system - Screw jack failed
- It took 8 hours to open hatch via alternative method
- Poor design and lack of full crew familiarity
