RIGHTSHIP

- Safe Mooring Practices
- Marine Pilot Transfer Arrangements

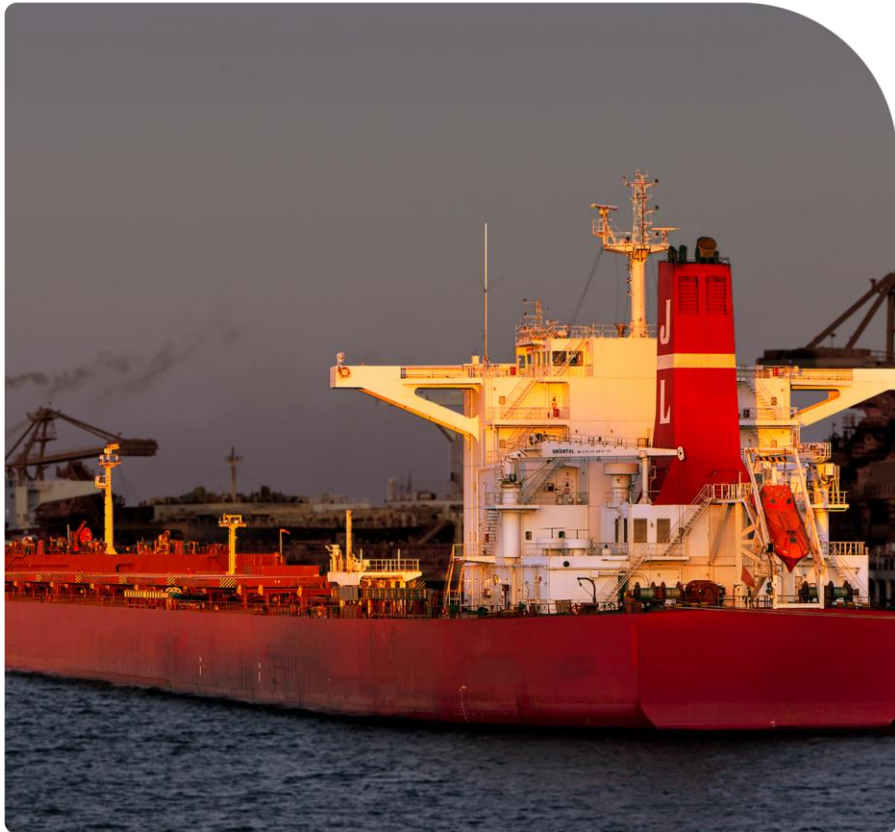
Mooring Lines and Tails

Condition and compliance with industry guidelines

- Lack of adherence to industry recommendations on the range of LDBF and its specific limit, which is sometimes higher or lower than industry norms when selecting lines and tails.
- Physical damage to the mooring lines

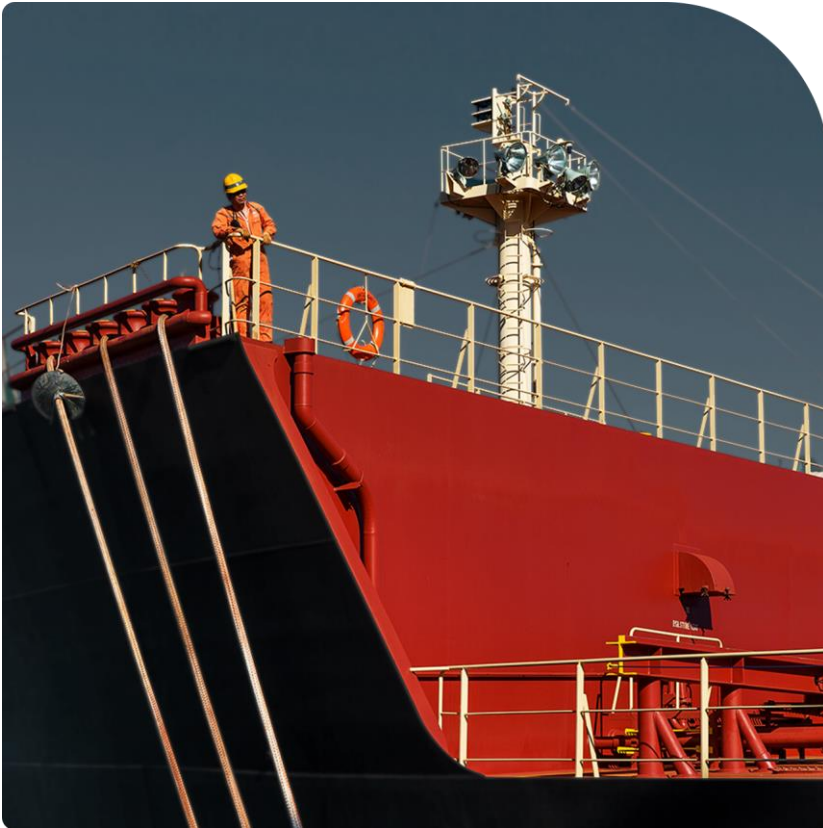
Mooring Line Management Plan

Lack of implementation

- Lack of LMP on board
- SDMBL was not included in the LMP
- Implementation of inspection, maintenance, and care of mooring lines and fittings, as well as execution of the LMP requirement or record keeping including certification

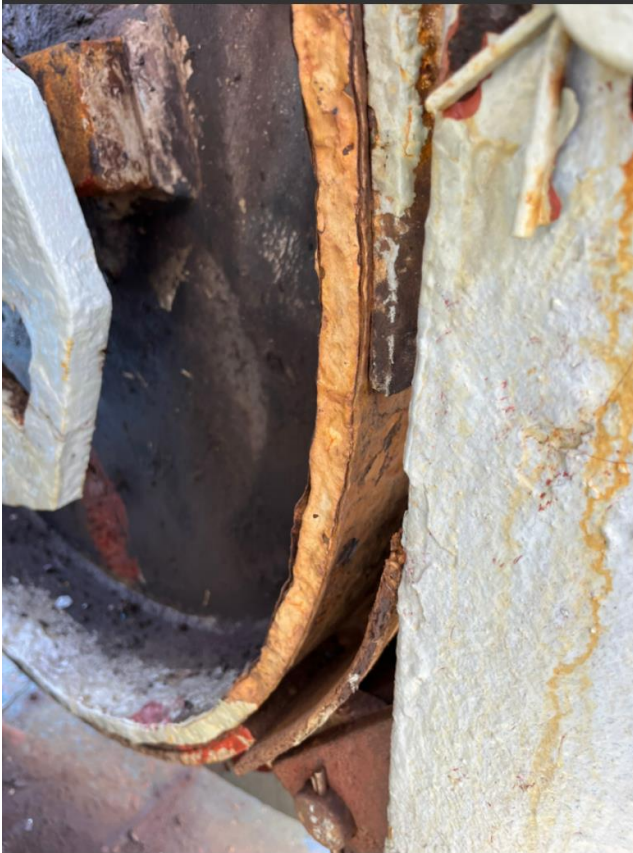
Lack of maintenance plan

- Hydraulic oil leakage
- Condition of brake drums
- Brake band material worn down / thinned

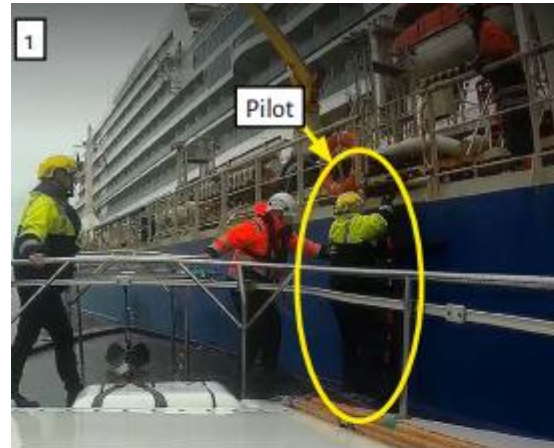
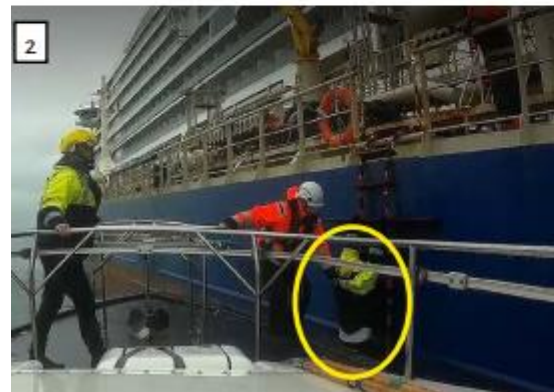
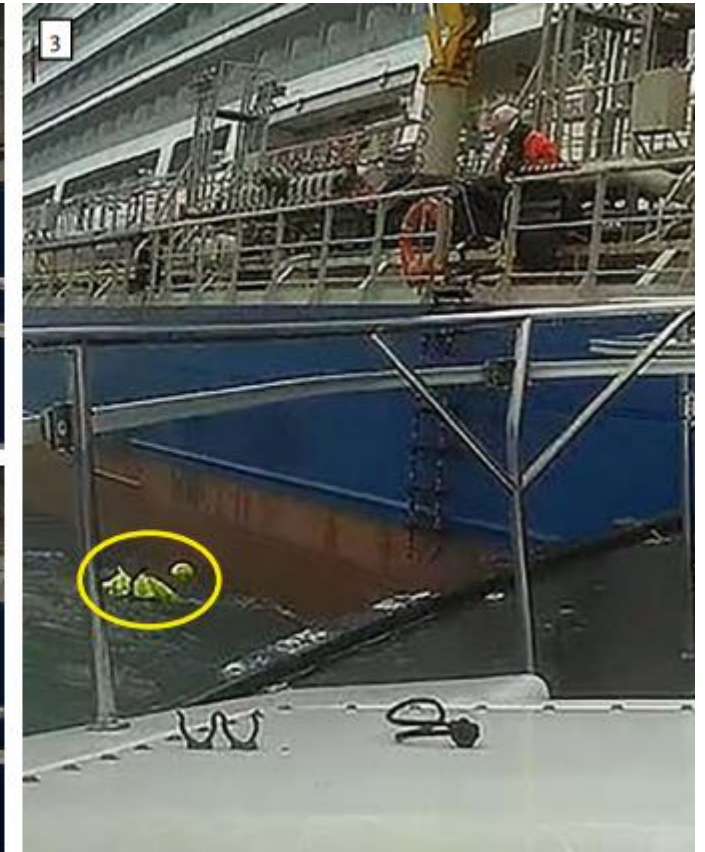
Pilot Ladders

- Proper rigging
- Maintenance of the pilot ladder
- Certification and marking
