CRANE WIRE FAILURE AND AFTERMATH

01 February 2023

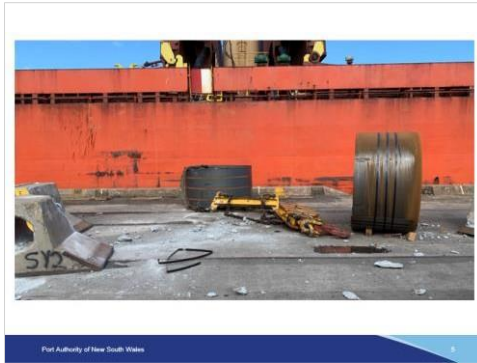
The photo shows what the arrangement should have looked like prior to the lift

The coil on the left was the one being lifted

It dropped onto the coil on the right, spinning it around approx. 90deg and pushing the concrete barrier away from beside it

The coil that fell then hit the barrier that was between the coils and pushed it out in the other direction, with the coil that fell landing on its face on the berth

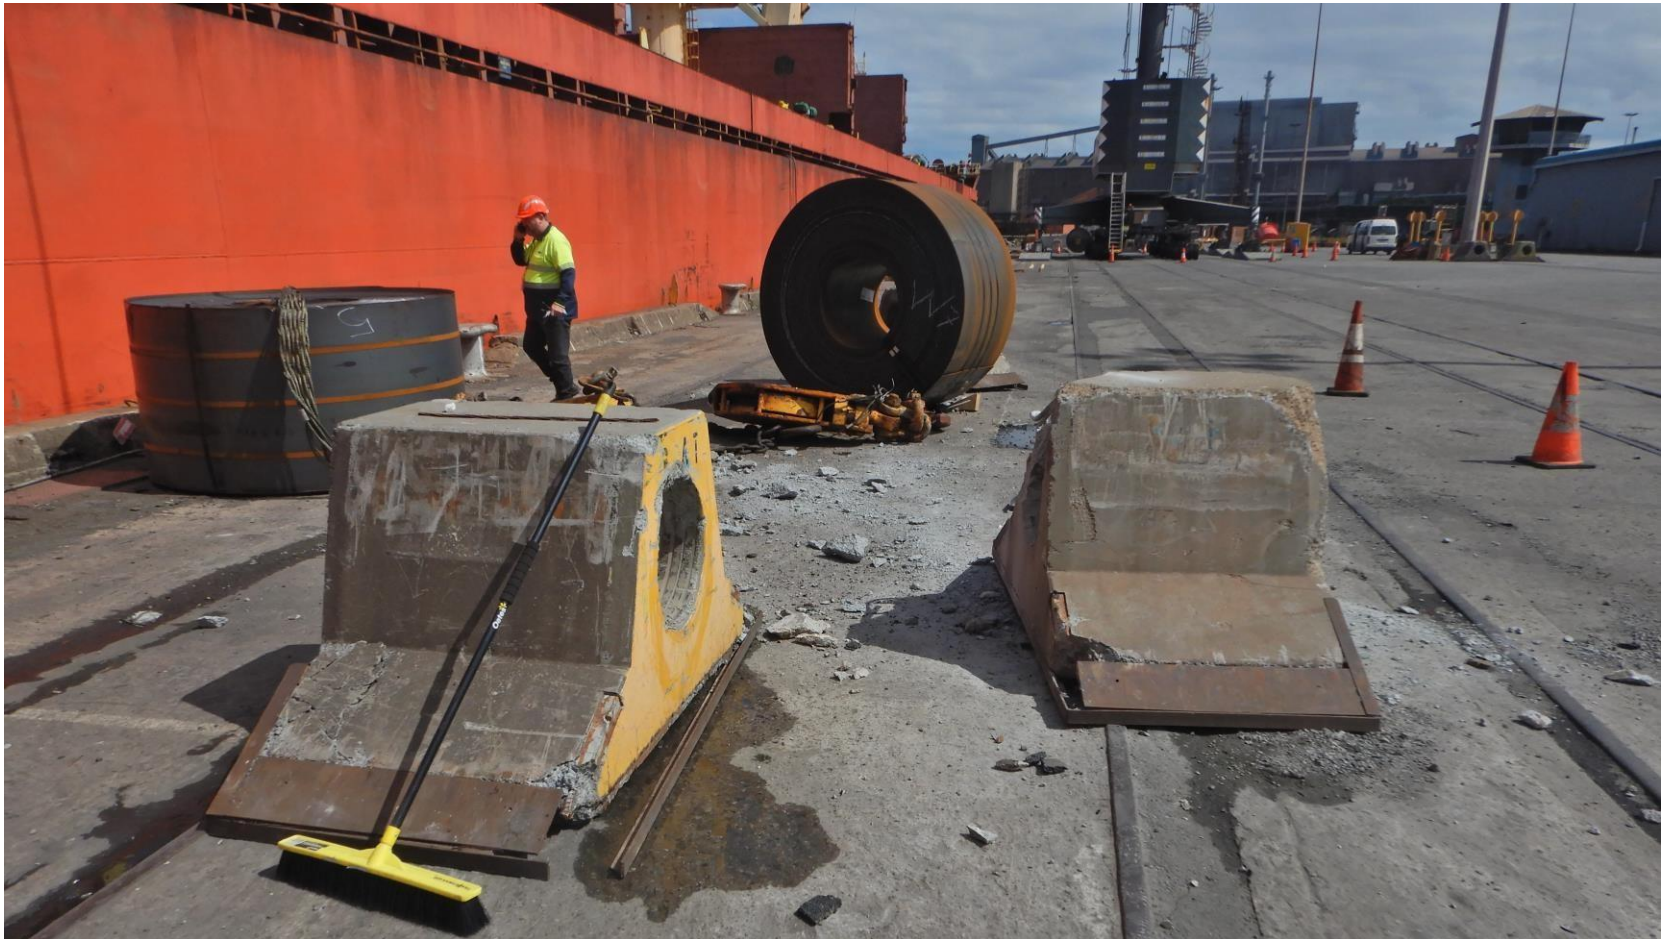
The Coil Landing on Another Coil Reduced Damage to the Wharf

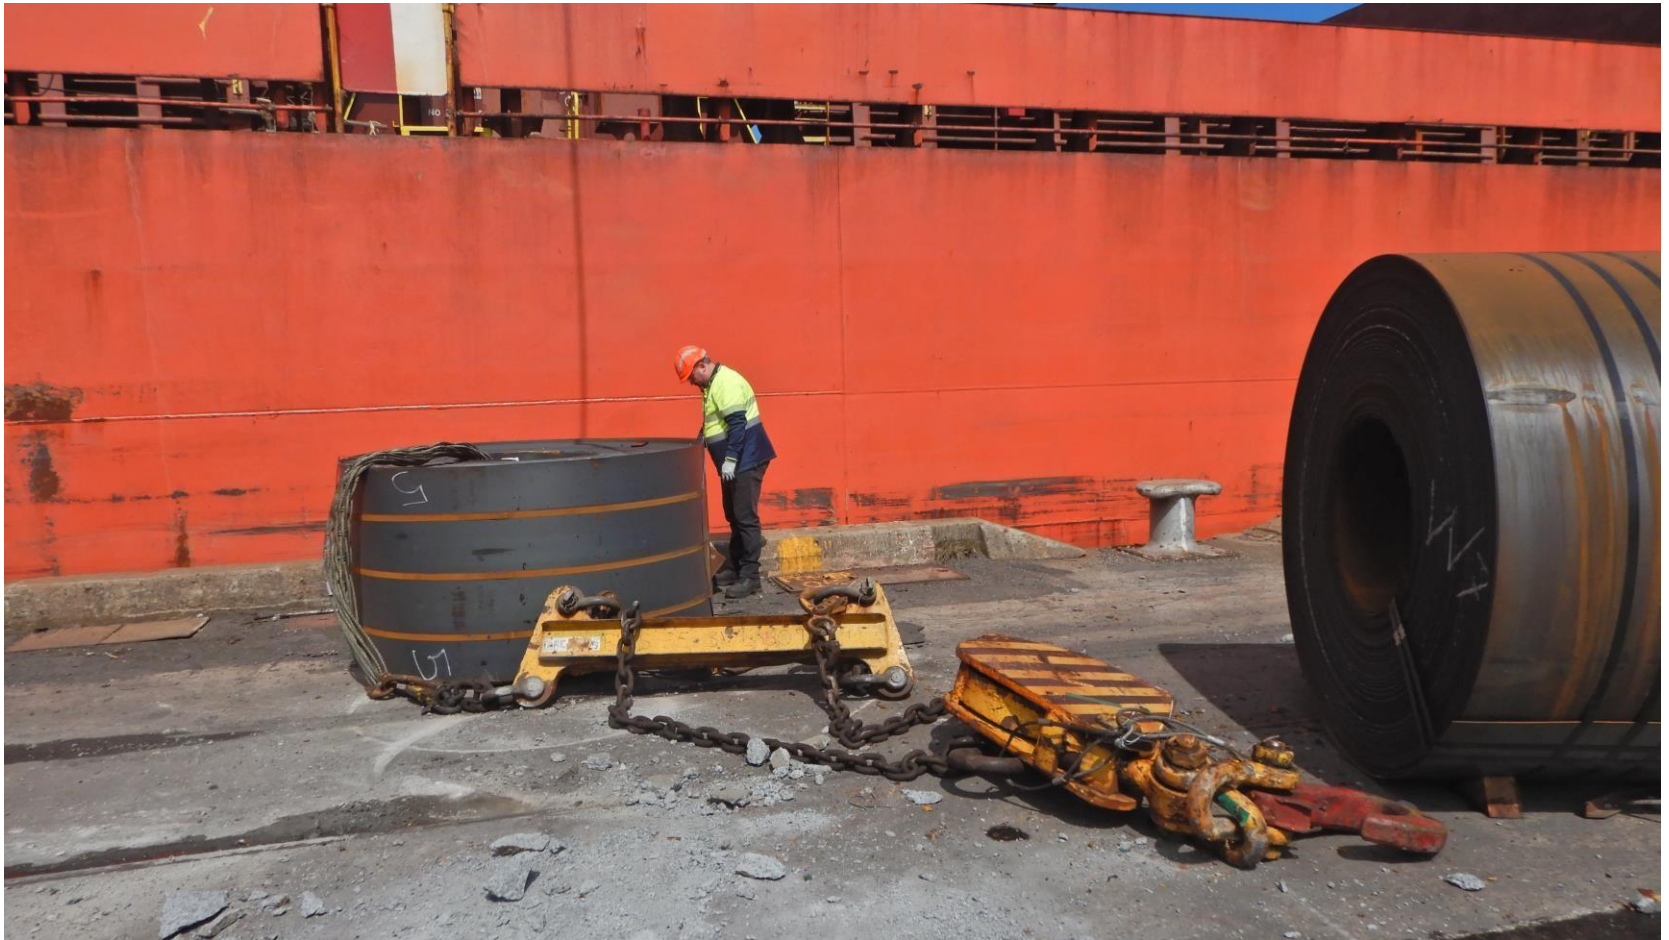
The Crane Hook and Coil Lifting Cradle Cracked Concrete

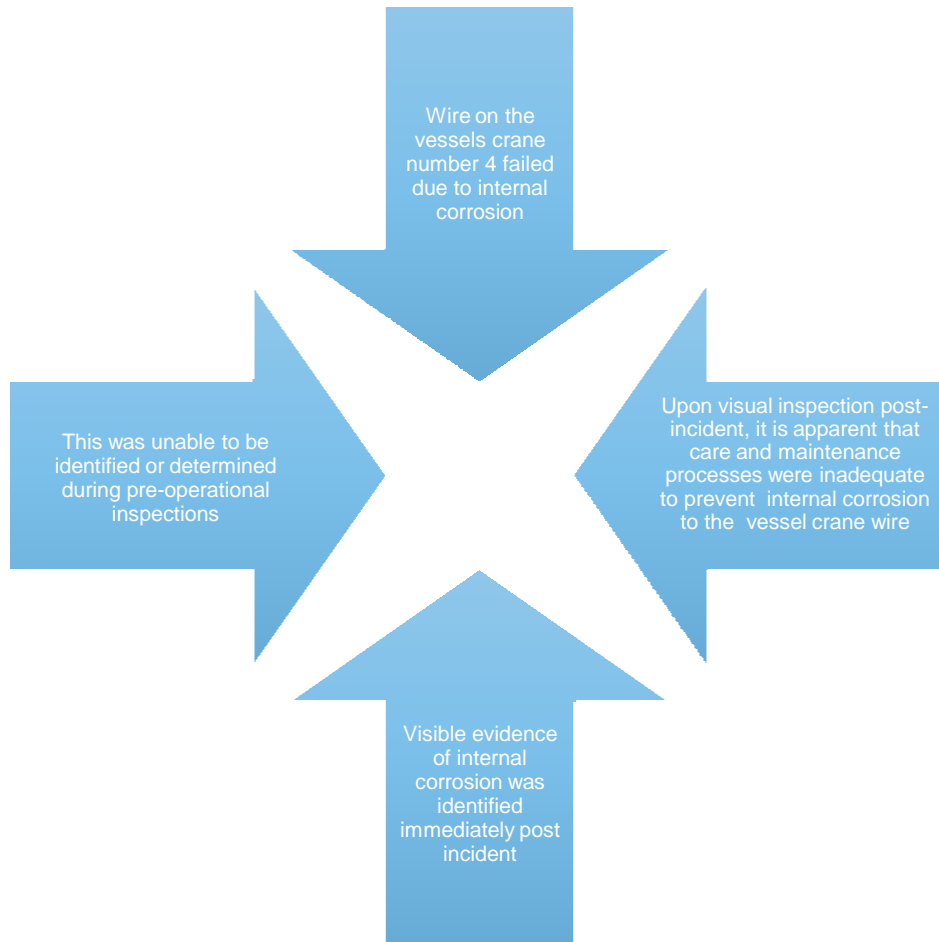
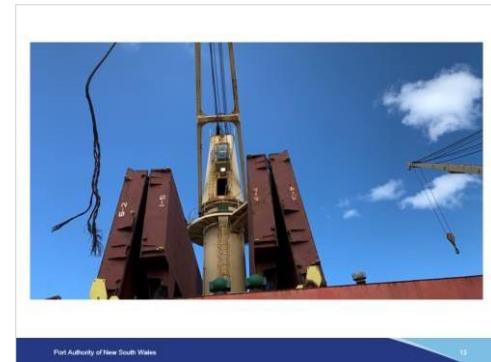
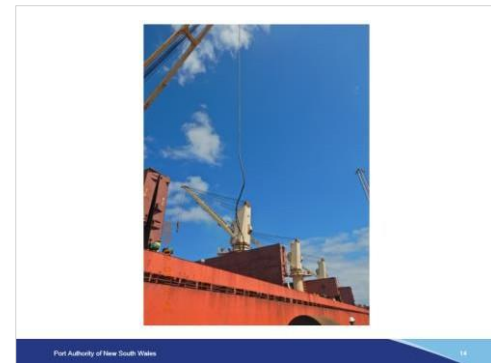
Post incident visual inspection of the broken crane wire strands is indicative of internal corrosion of the crane lifting wire

Root Cause Determined by Stevedores

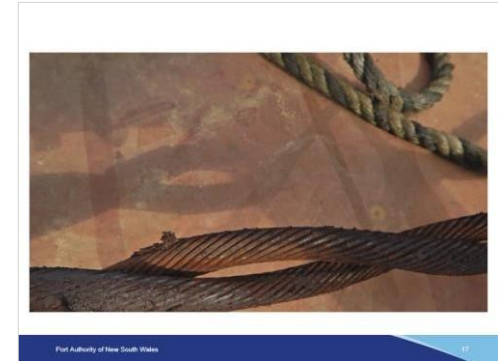
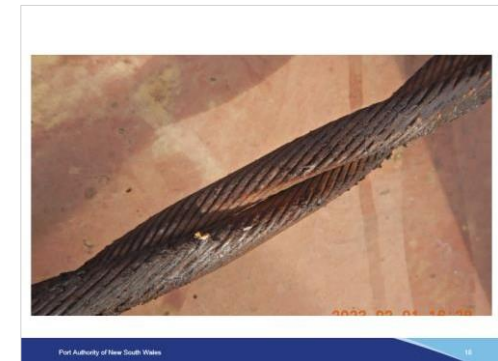
03 Feb 2023 examination of parted wire – internals/ core dry and or corroded

Wire's core appeared dry and surface corrosion commonplace

Better Inspection of
Crane Wires by
Stevedores Prior Starting
Cargo

Vessel Planned
Maintenance for Wires
Including Replacement
Cycle

Consideration on
Ongoing Continuous
Maintenance Program
for Cranes
