# FREMANTLE PORTS

Incident and Process improvement

# **Serious Marine Incident - Marine Pilot Transfer**

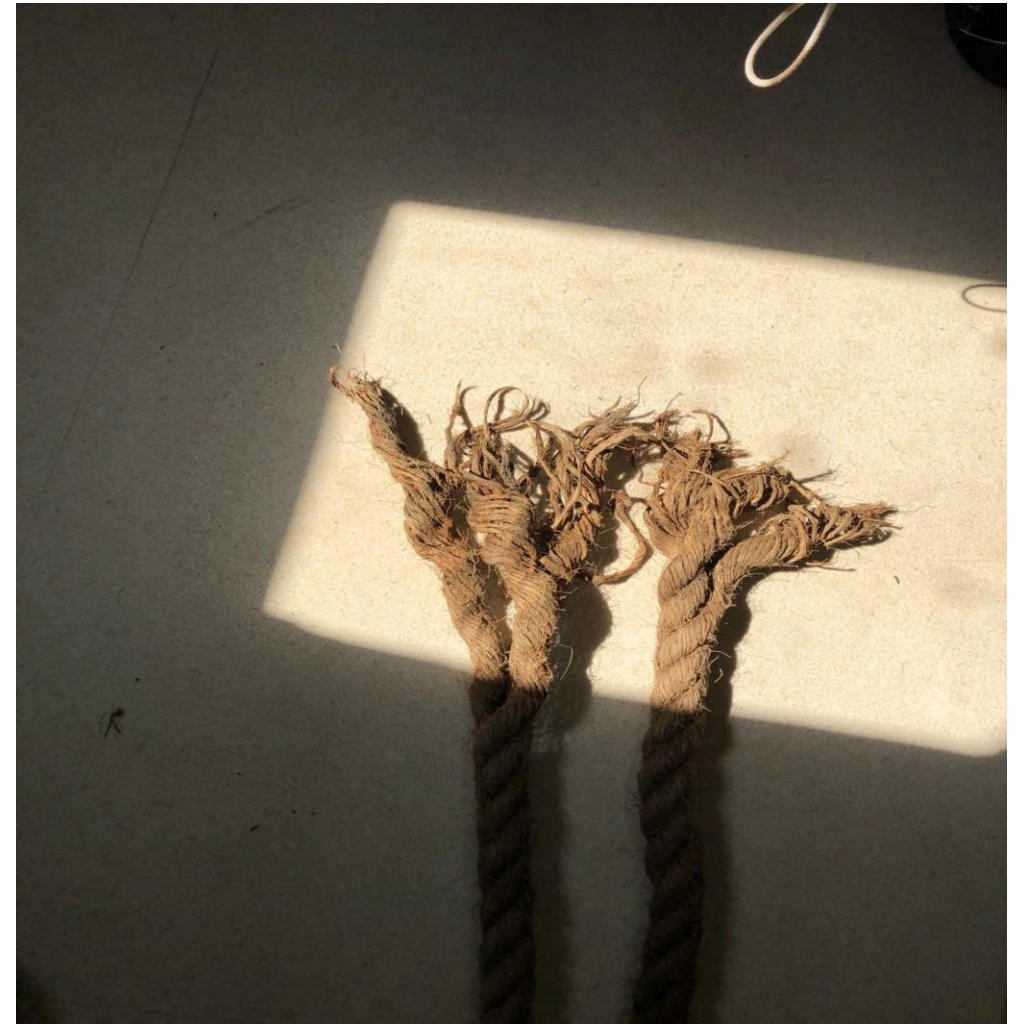
- 25 August early am
- Marine Pilot fall from height during disembarkation
- Unsafe pilot embarkation arrangements – parting of man-ropes
- Lack of maintenance and inspection regimes
