Fatality due to Electrocution

The Case

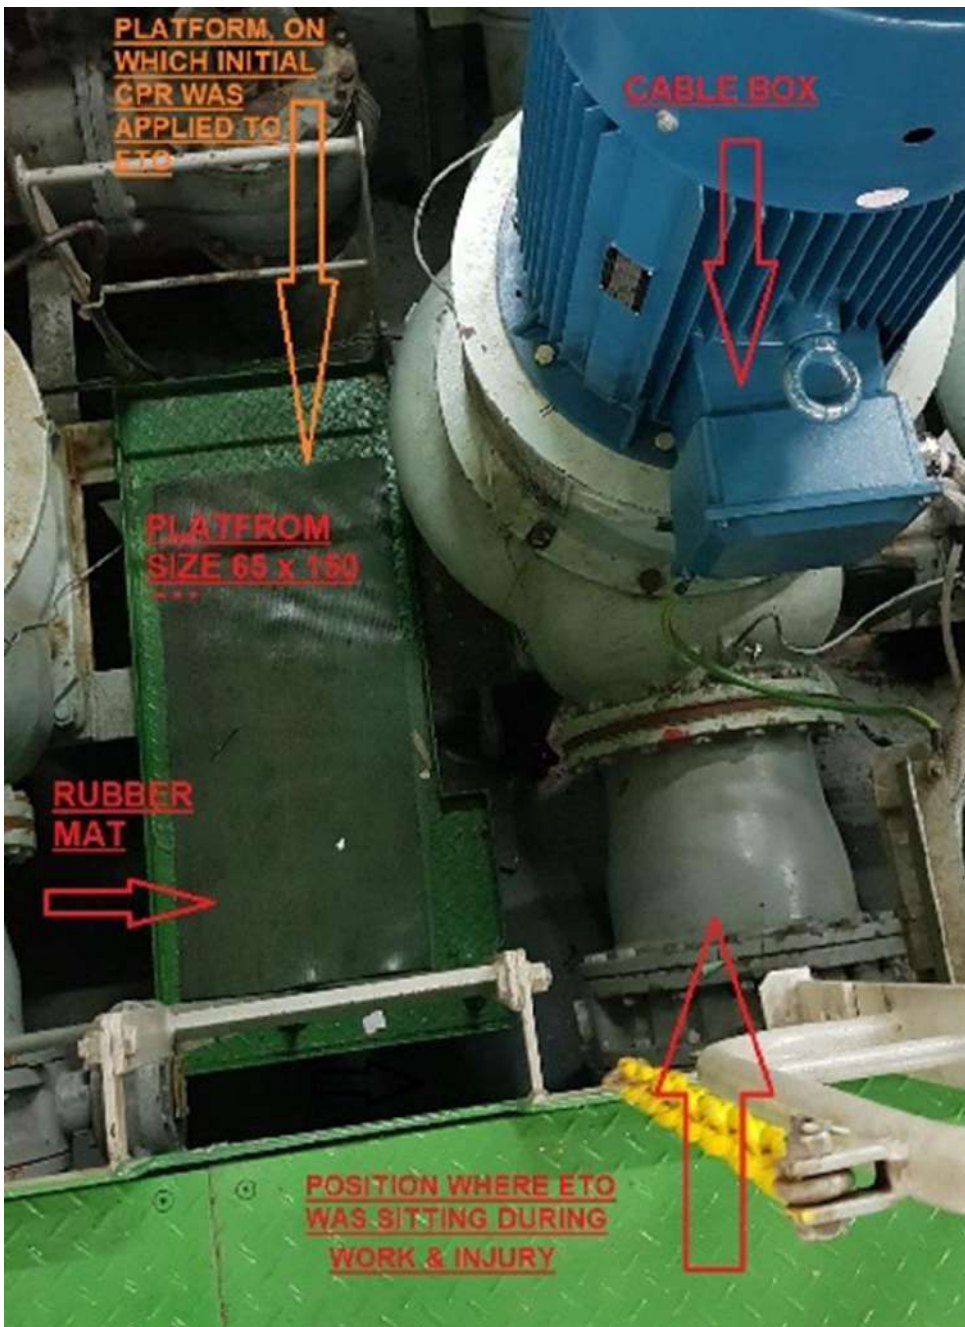
Around 1455 LT:
Electrical Officer, sitting on the steel pipe completed connecting the connected the main power cables of the motor (440V) and was in process of connecting the power cables of the space heater (220 V) when he got electrocuted.

- It is presumed that a careful check to ensure none of the wires is live was not carried out.
- Even though ETO was wearing rubber-soled shoes, he was seated on a pipe without using any insulation mat, which completed the electrical circuit when he touched the wires
- As per the Maker's drawing, putting off the main circuit breaker should have made all supply cables dead, but modification in the circuit was carried at the time of installing VFD, while the vessel was under previous management. This change was not present in the drawing kept at the control panel of the MSWP. Possibly, this detail was missed by the Electrical Officer when checking the drawing.
- At the frequency drive panel, a single-pole isolation switch was installed instead of a two-pole switch, which would have prevented power on both the cables of the space heaters.

- Ships drawings were amended as per the changes in the circuit, these amended drawings were kept at the main circuit breaker and starter panels of the pumps. Obsolete drawings were removed from all locations and destroyed.

- 220V auxiliary power supply for each of the three seawater pumps was provided directly from their 440V individual breaker supply in the ECR. For this solution, an additional step-down transformer, 440V to 220V, was installed after the main breaker for each pump. The auxiliary power for each pump was then taken from its transformer. Hence, only one switch is to be turned off to stop the main power supply and the auxiliary power supply.

- Electrical Isolation permit and the isolation sections of other permits amended to include the following points:
 1. Has there been any modification of equipment wiring? If “Yes” is the latest drawing available.

2. Non conducting material placed at the worksite to ensure that circuit with the earth is not completed. (such as insulation mat)
