Association of Resource Companies, Ship Operators, Ports & Terminals

Pilot Transfer (Ladder) Arrangements

Pilot Transfer Issues - Sydney

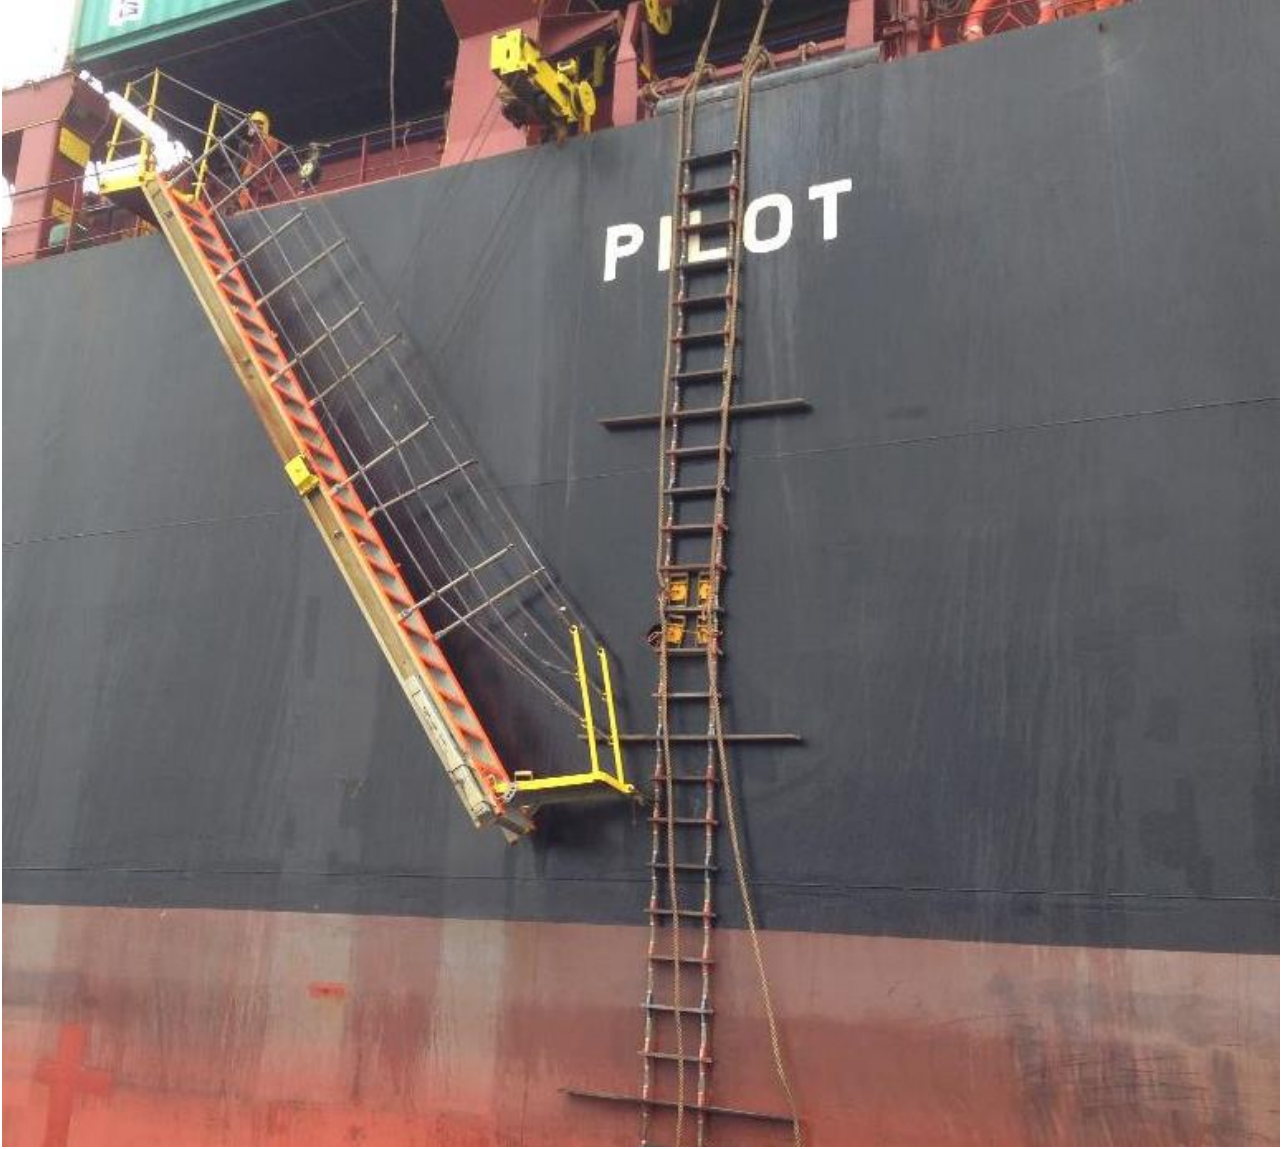
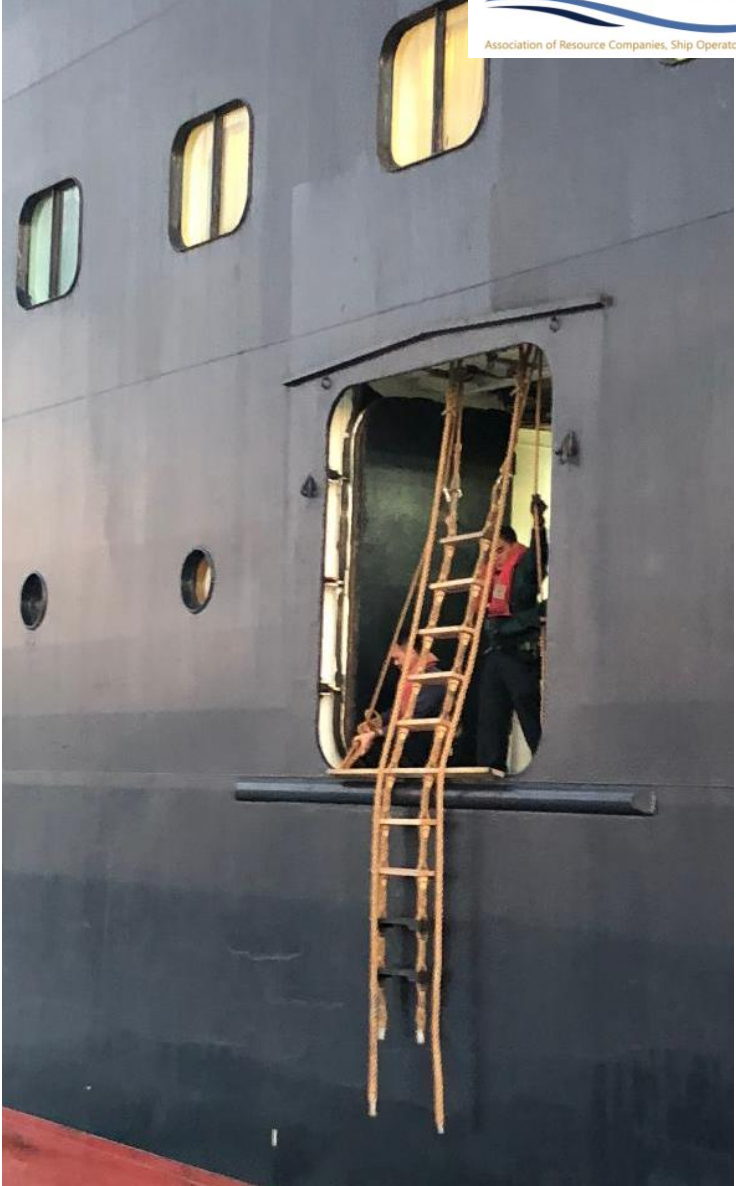
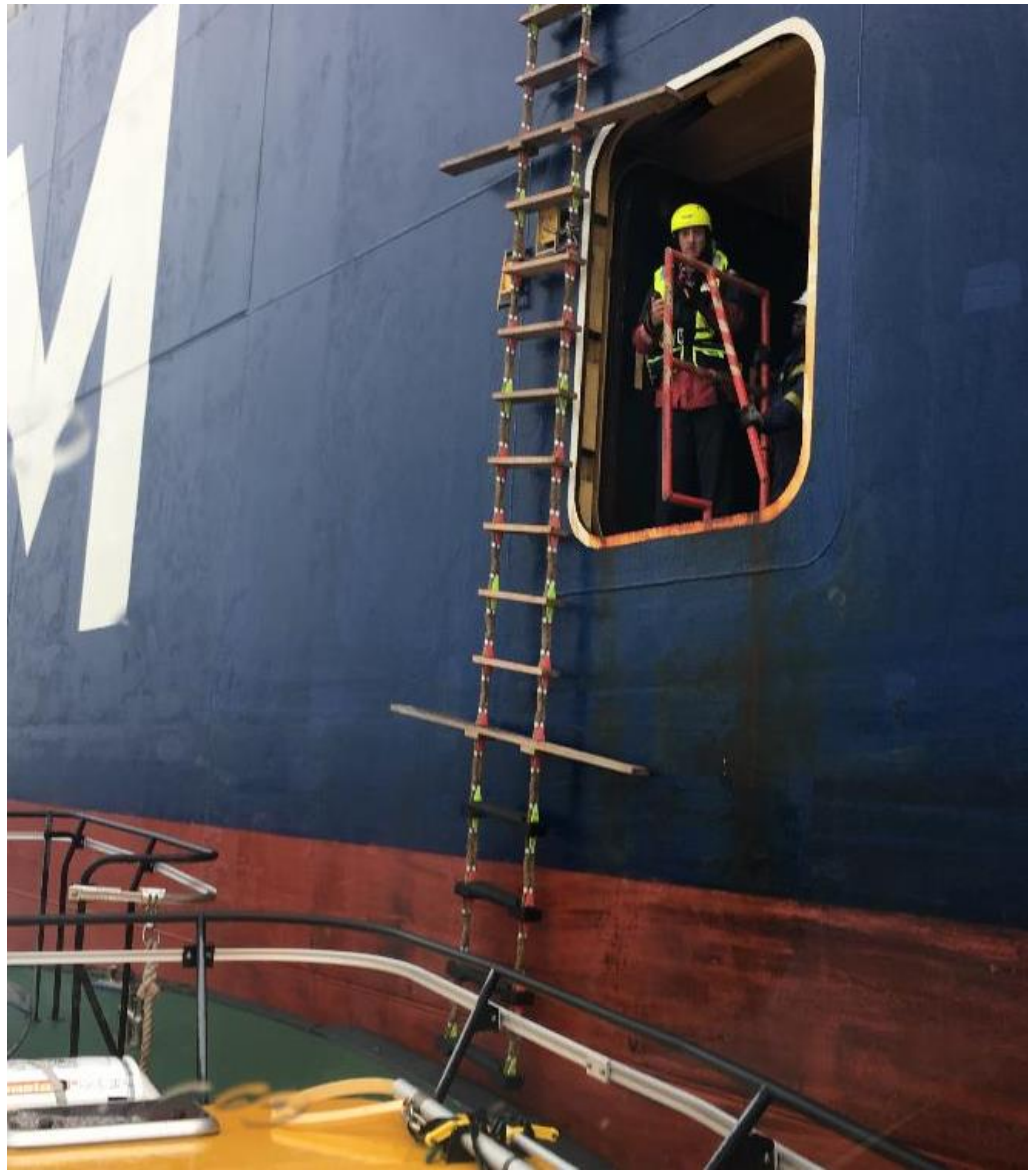
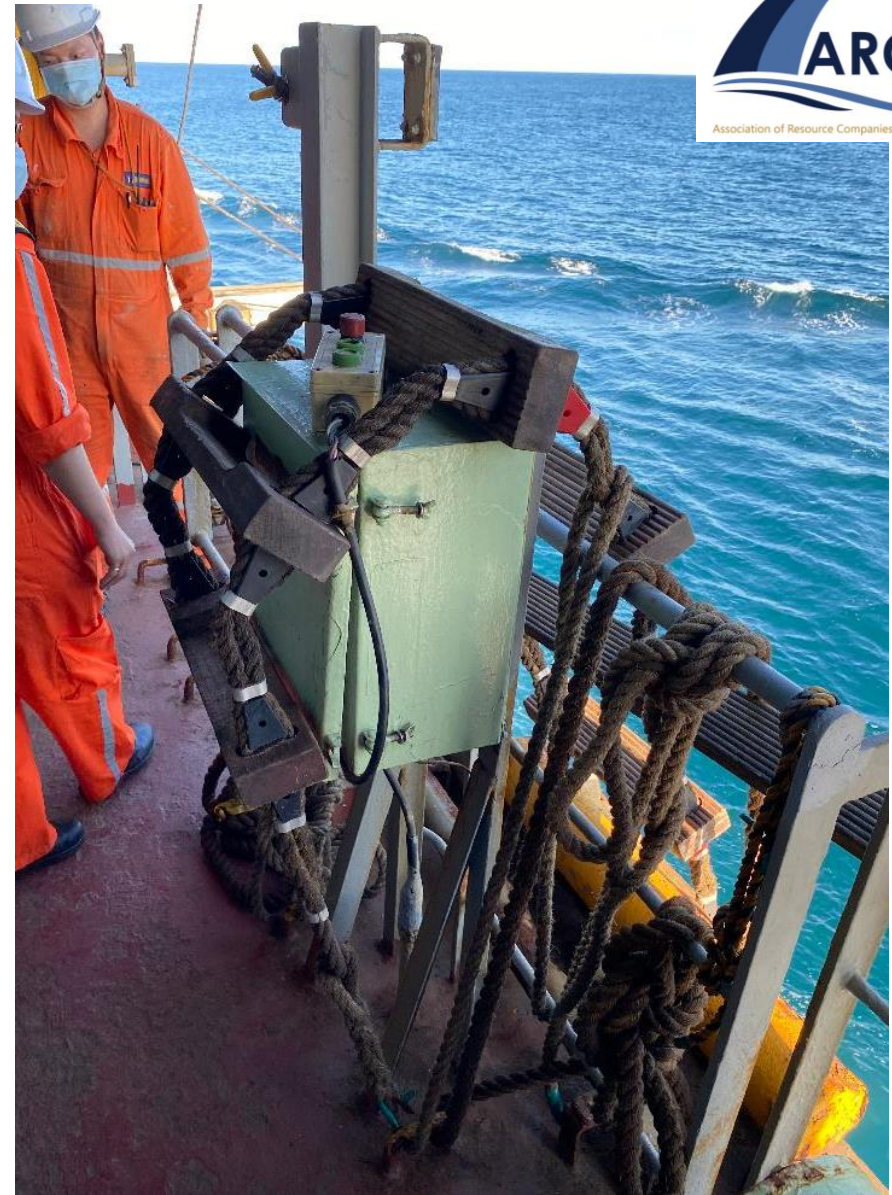
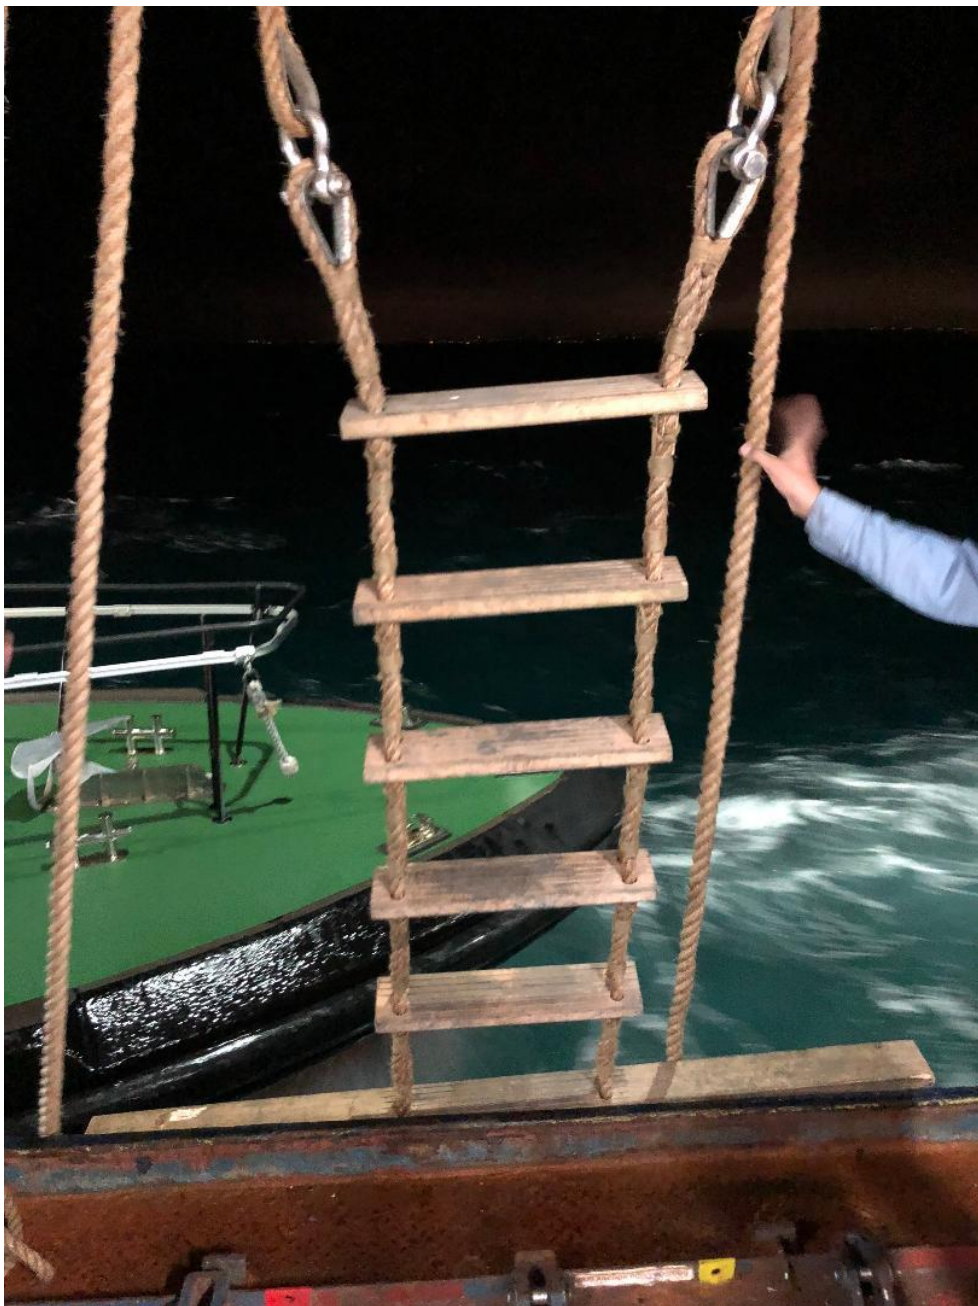
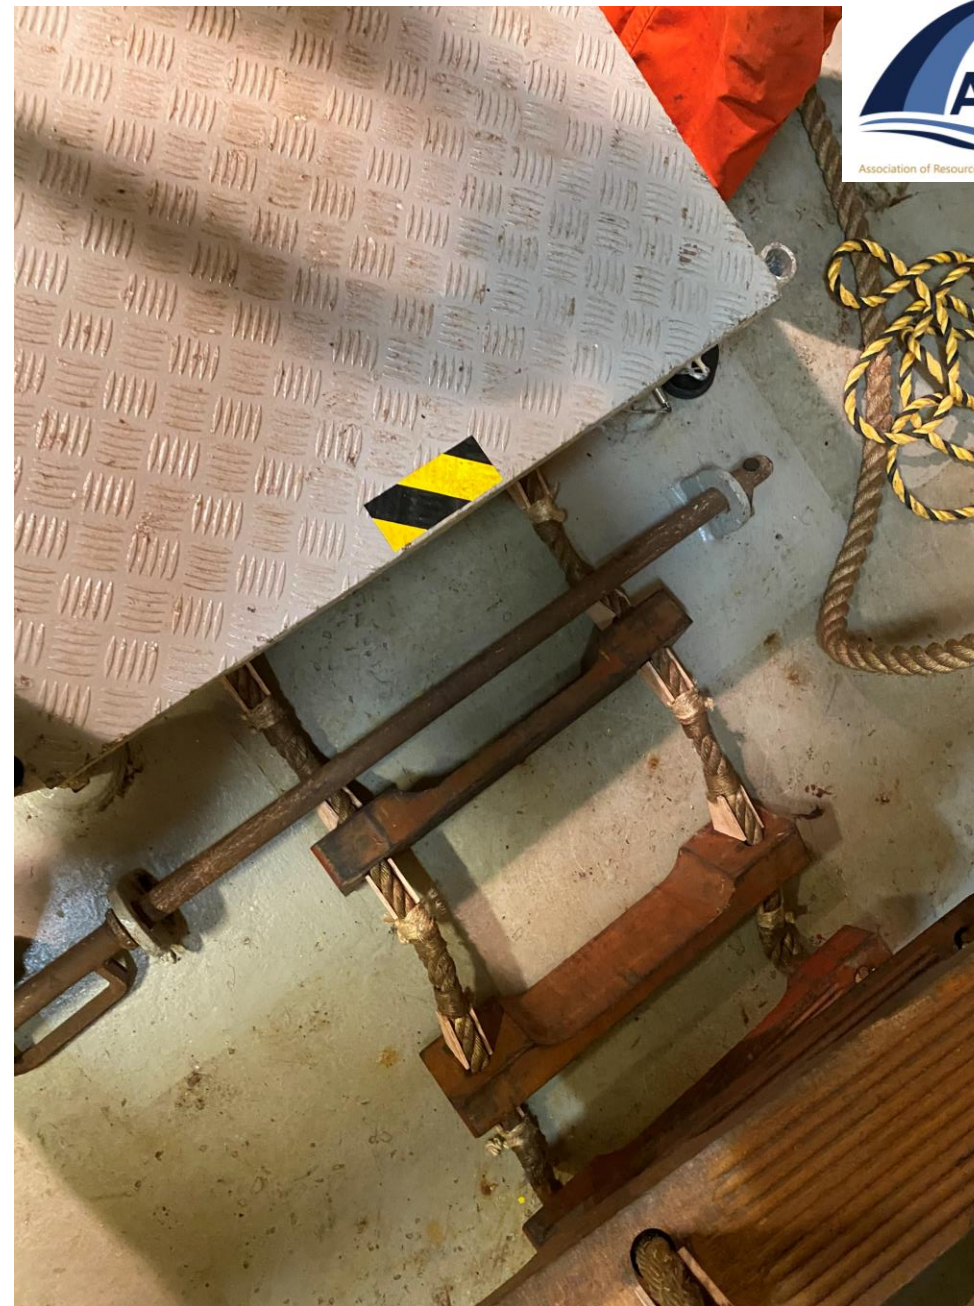
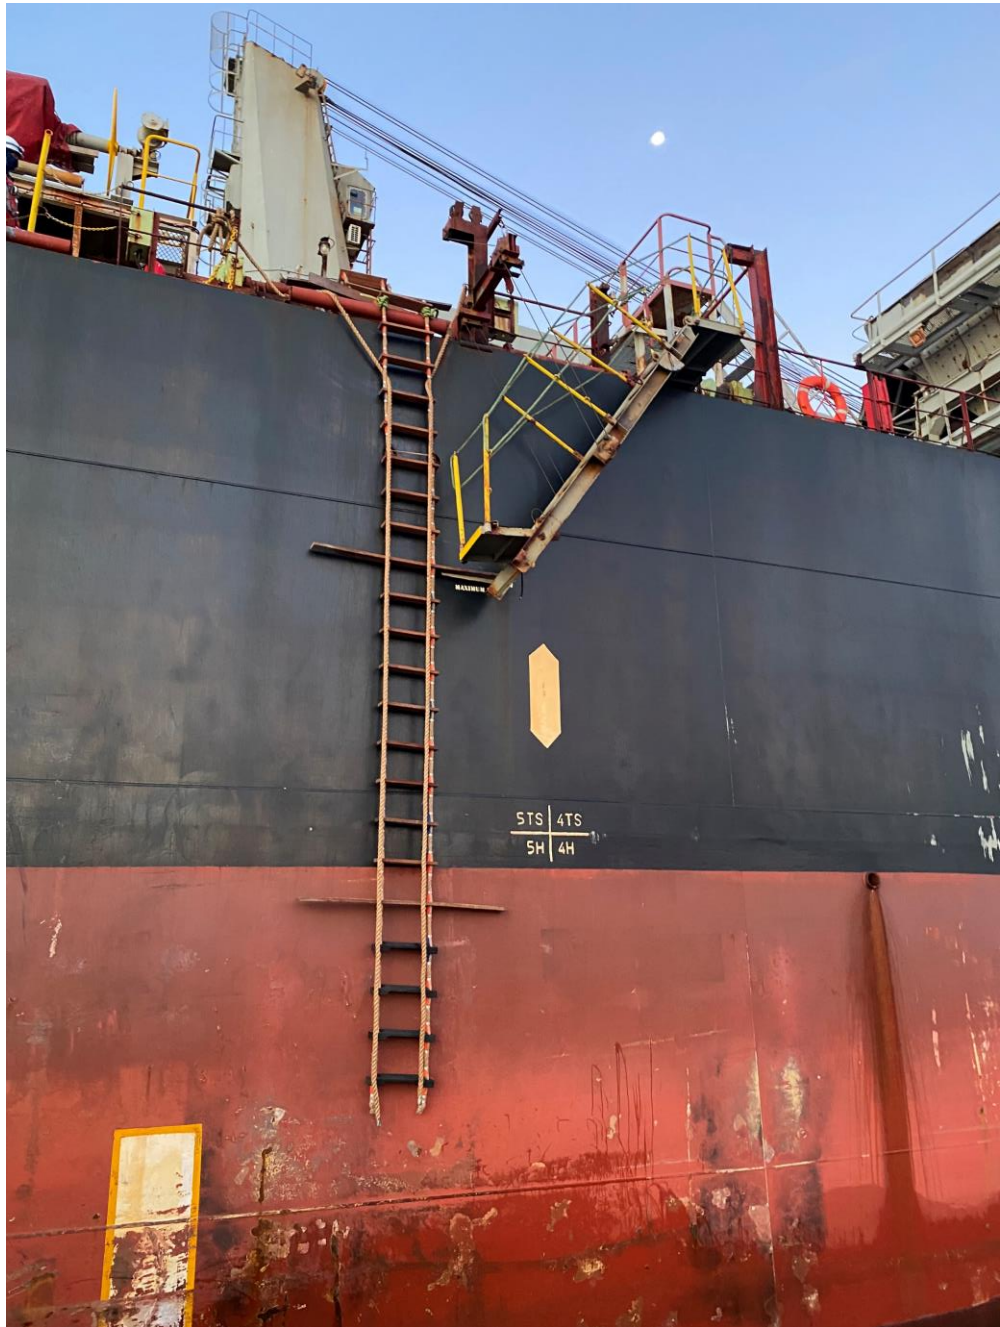
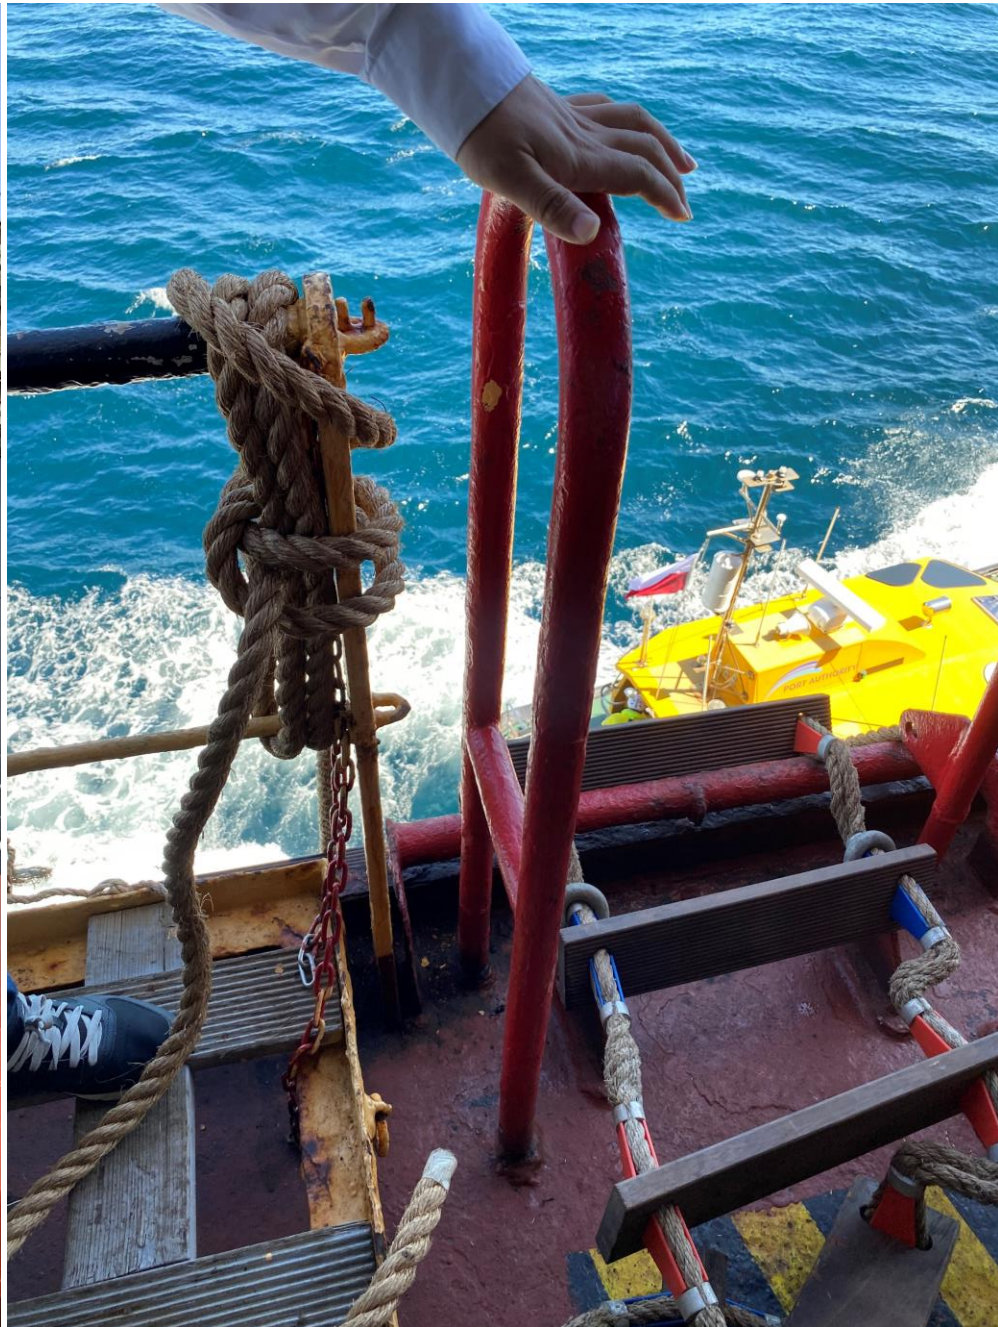
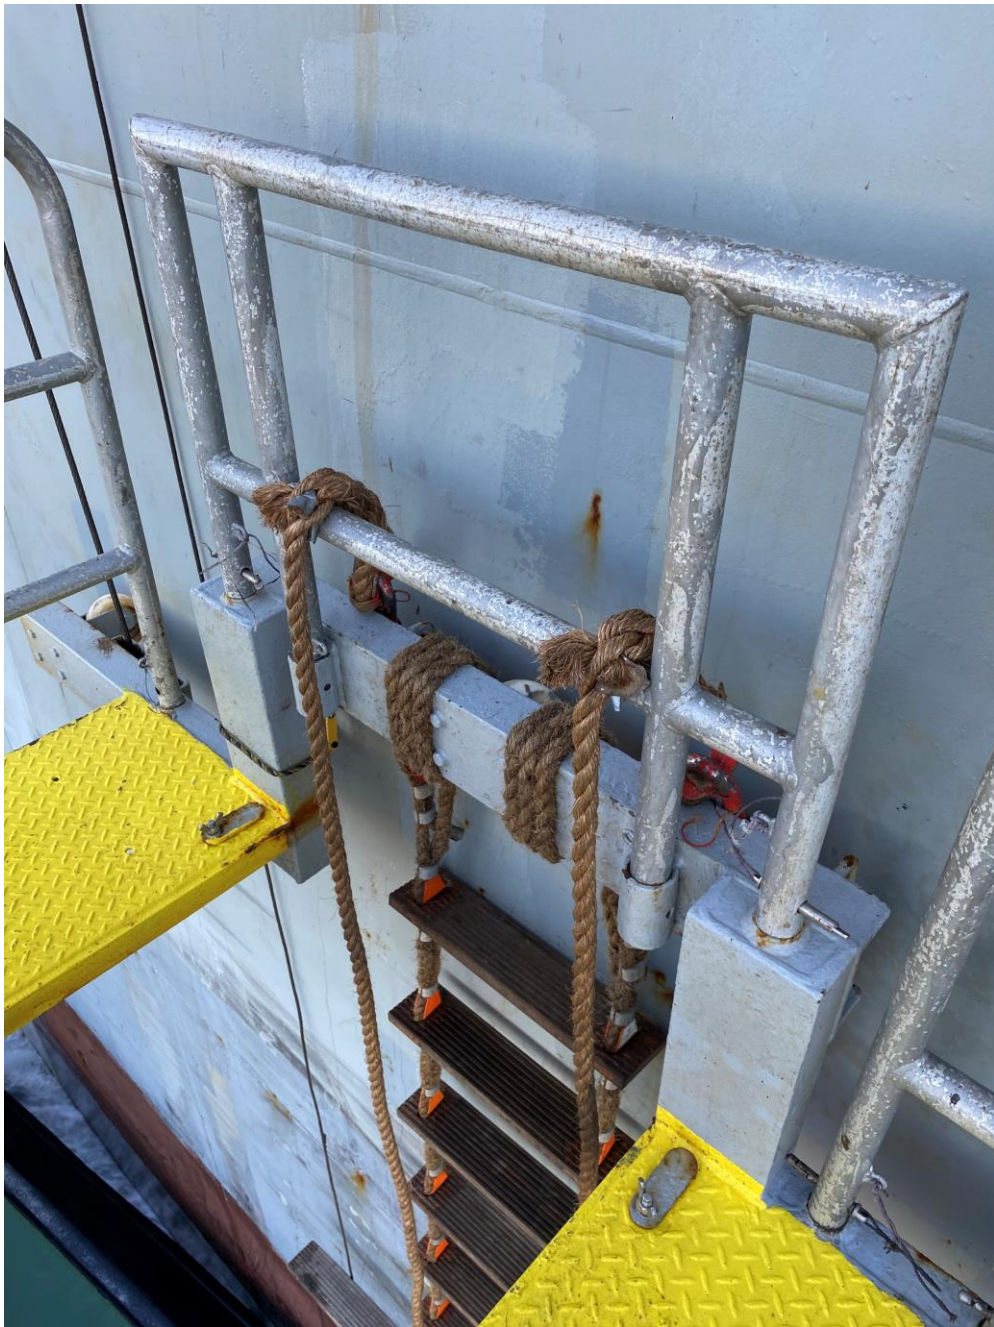
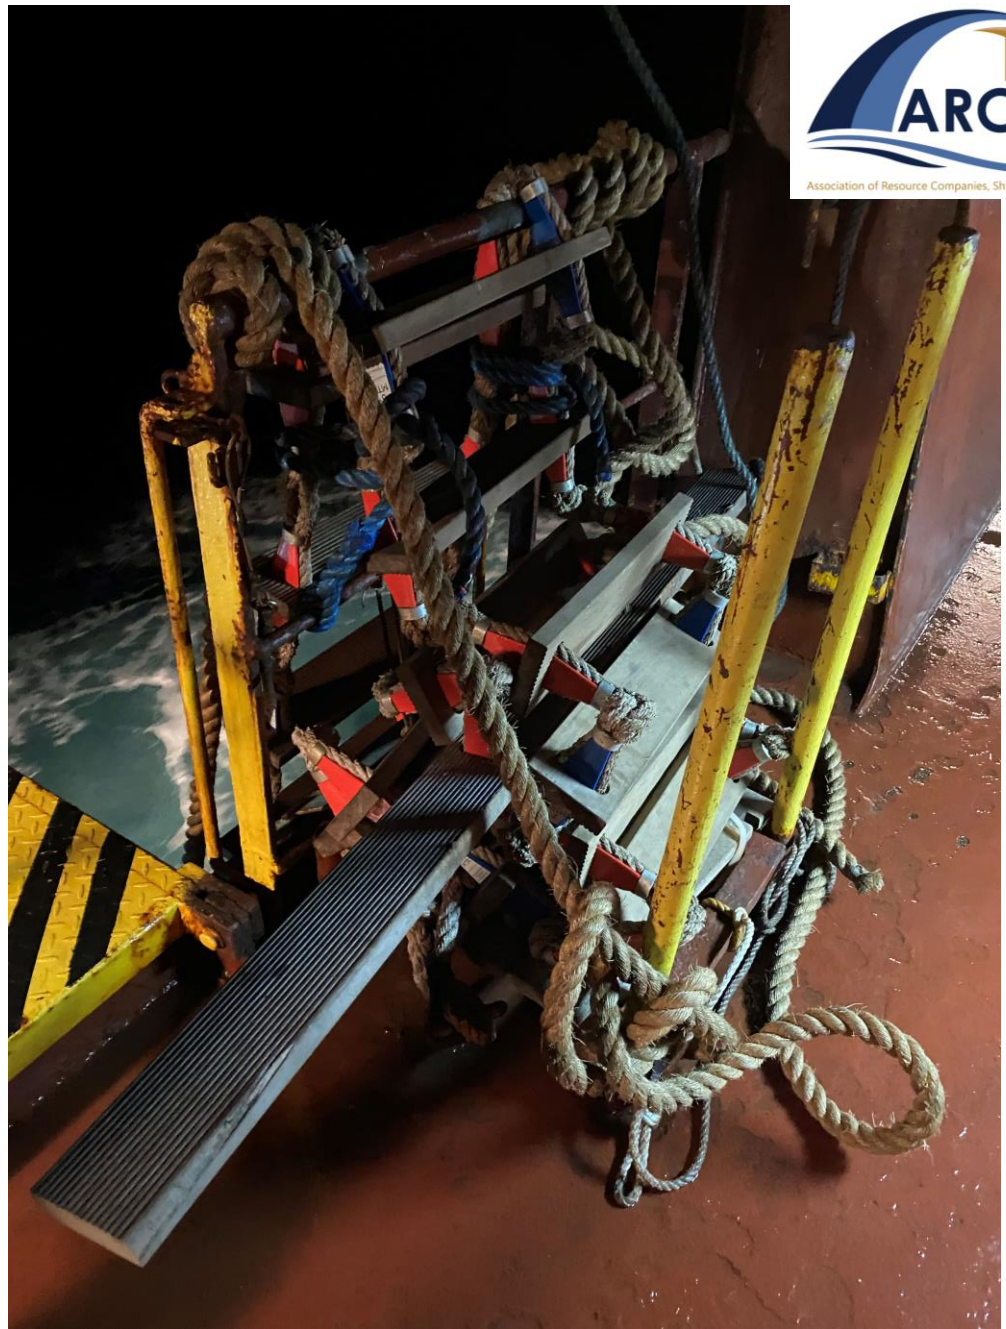
Examples of non-compliance

Fremantle Ports experienced a serious incident during marine pilot transfer operations recently. The incident involved a fall of the marine pilot, from a vessel on to the pilot boat landing deck due to failure of a pilot boarding arrangement component (manropes). The marine pilot suffered significant injuries due to the fall.
