BEST PRACTICE AND MARINE SAFETY CRITERIA BULLETIN 02-2022

BPMSCB 02-2022: Safety of Marine Pilot Transfer arrangements

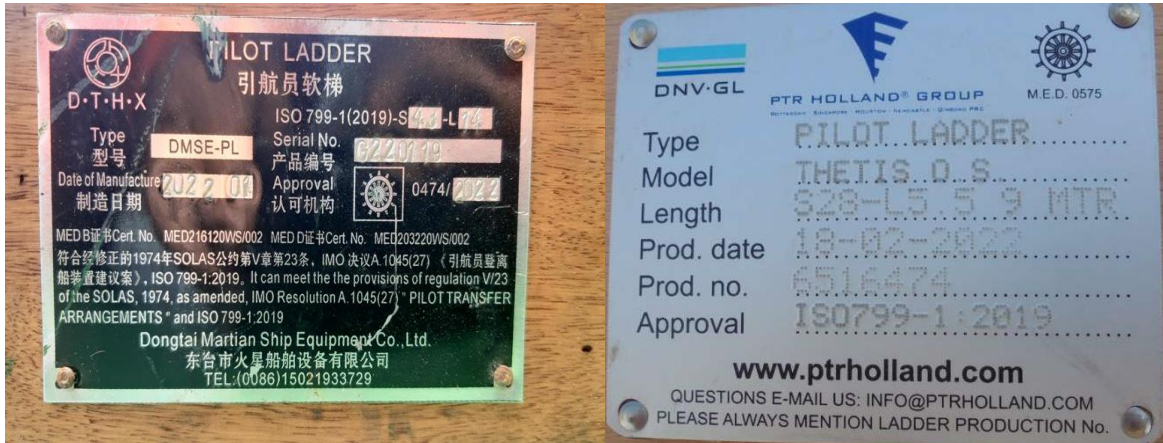
(Examples of compliant identification plates)

Pilot ladders **MUST** be certified by the manufacturer / Classification Society as complying with requirements as mentioned under either IMO Resolution A.1045(27) or International Standard ISO 799-1:2019. **Proof of certification MUST be kept on board and produced when requested by Fremantle Ports'.**

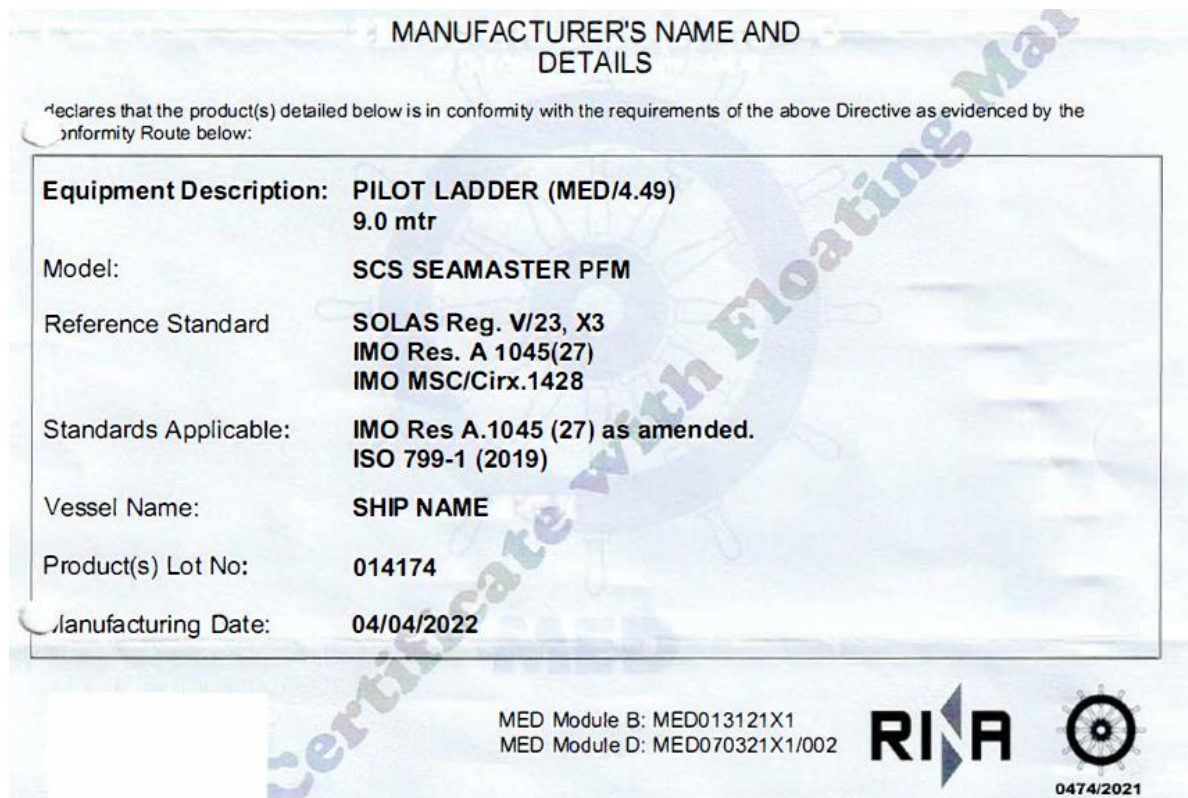
(Example of a compliant pilot ladder certificate)

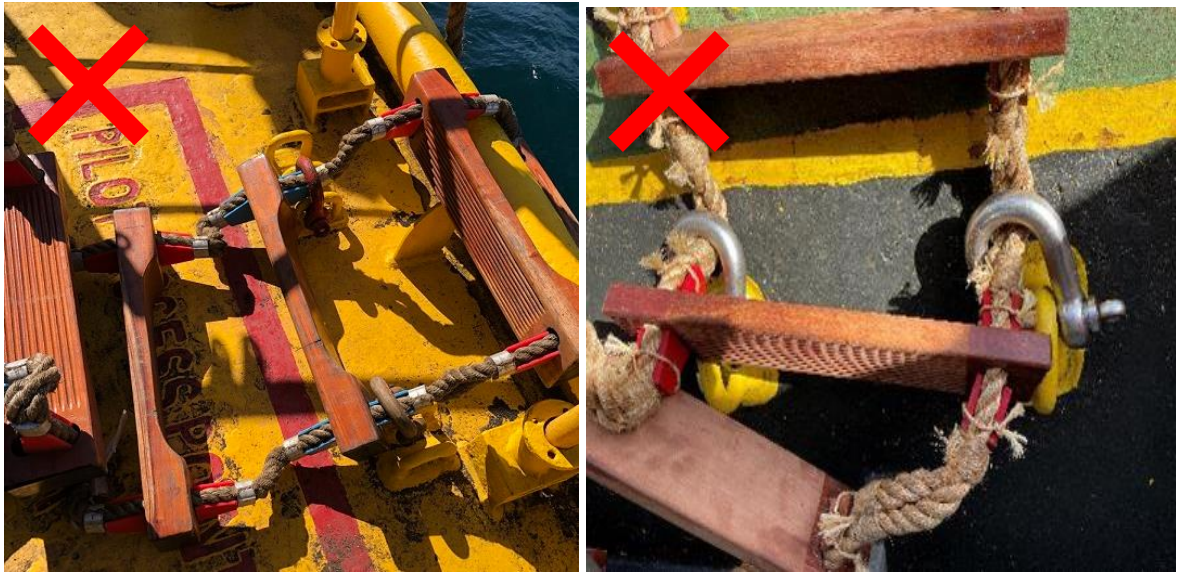
- **Use of shackles for securing - The use of shackles to secure / choke pilot ladder side ropes when securing on deck is PROHIBITED.** Using shackles to shorten / secure ladders causes the weight of the ladder to be taken up by the shackles impacting directly against the mechanical securing clamps (widgets) which secure the ladders treads in place, including the seizing twine and will eventually damage them

(Examples of non-compliant securing methods using shackles)

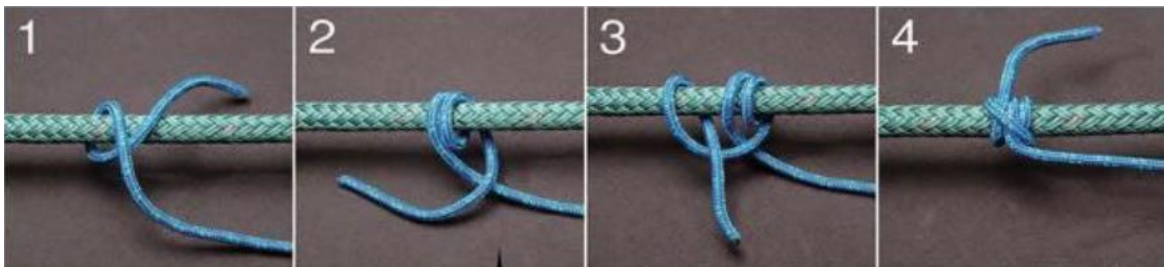
(The rolling hitch)

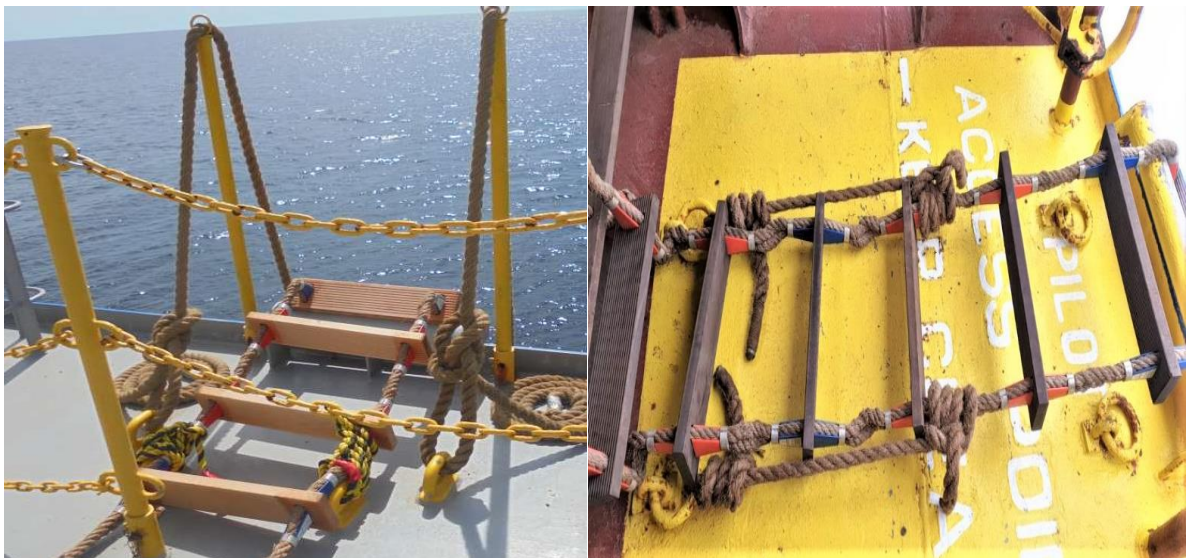
(Compliant securing methods - Use of rolling hitches)

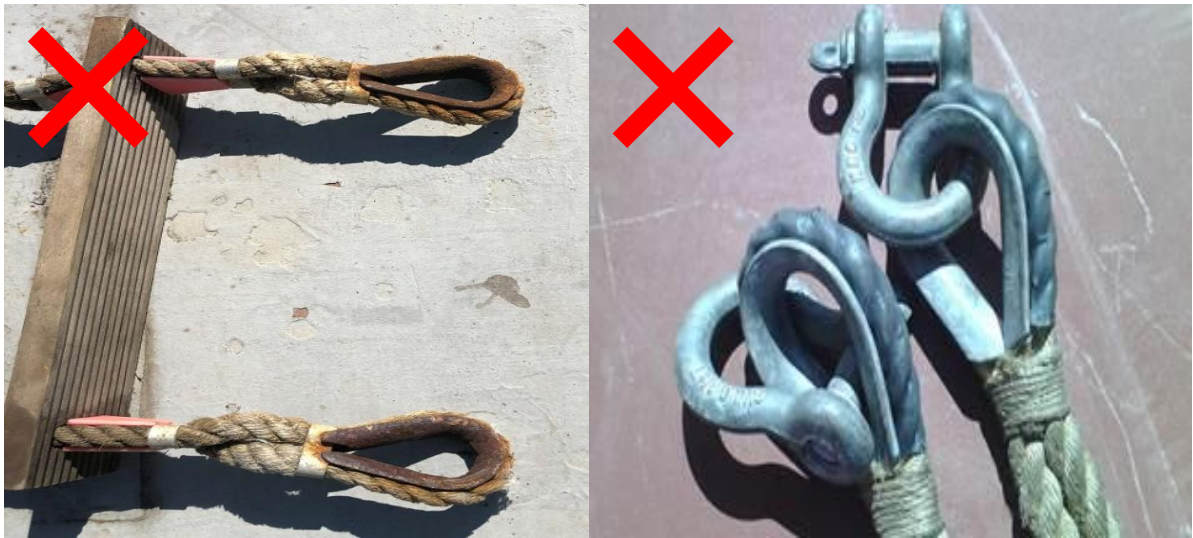
- **Attention to end points (Thimbles)** - Corroded end point thimbles can damage the side ropes, thereby leading to the failure of the side ropes. The rope portion around the thimble must be inspected as part of the inspection routine. Heat shrunk plastic covering for end points must not be used as it prevents detailed inspection of the rope area

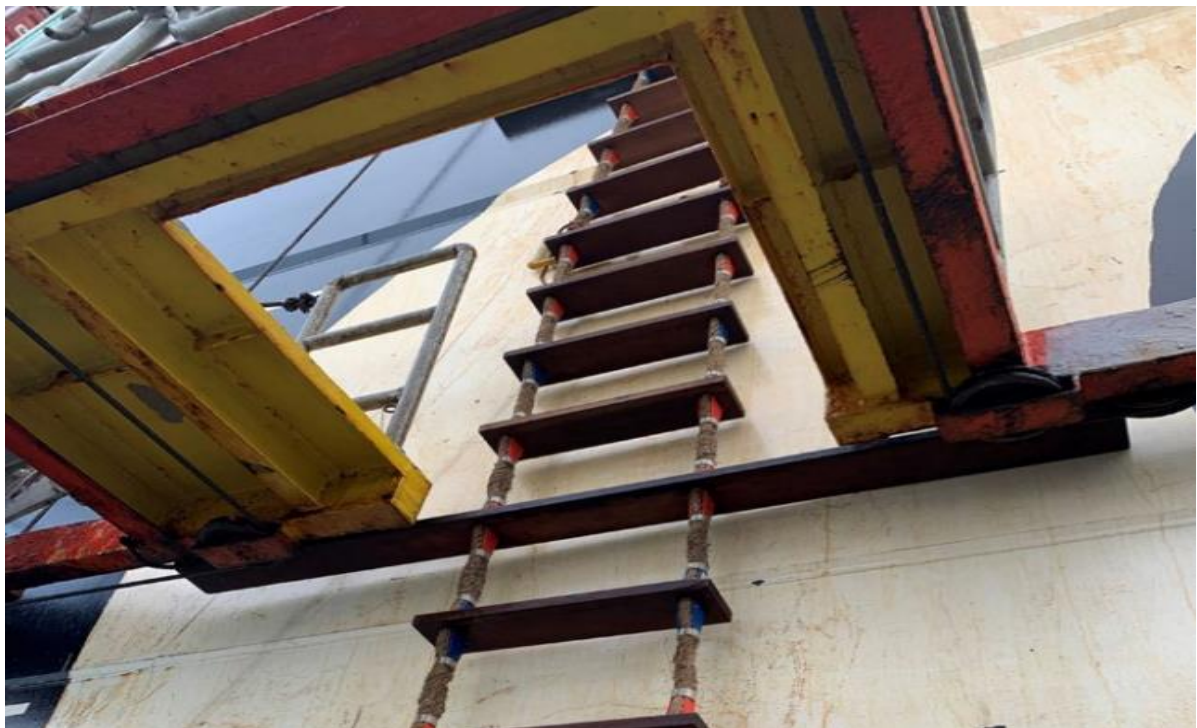
(Reference - ICS Shipping Industry Guidance on Pilot Transfer Arrangements)

The pilot ladder and manropes shall be rigged through the trapdoor extending to a height of at least 2 metres above the platform.

When a combination ladder is used, the lower platform of the accommodation ladder should be in a horizontal position and secured to the ship's side. If a trapdoor is fitted in the lower platform to allow access from and to the pilot ladder, the trapdoor should open upwards and be secured either flat on the embarkation platform or against the rails at the aft end or outboard side of the platform and should not form part of the handholds.

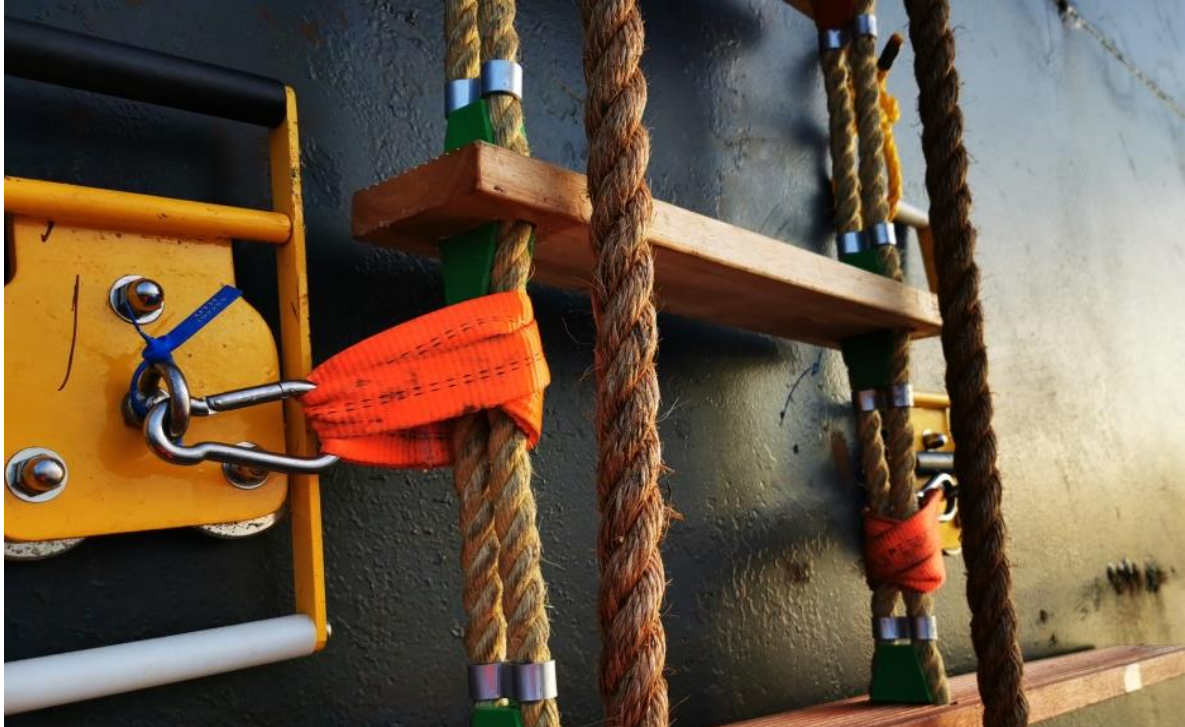
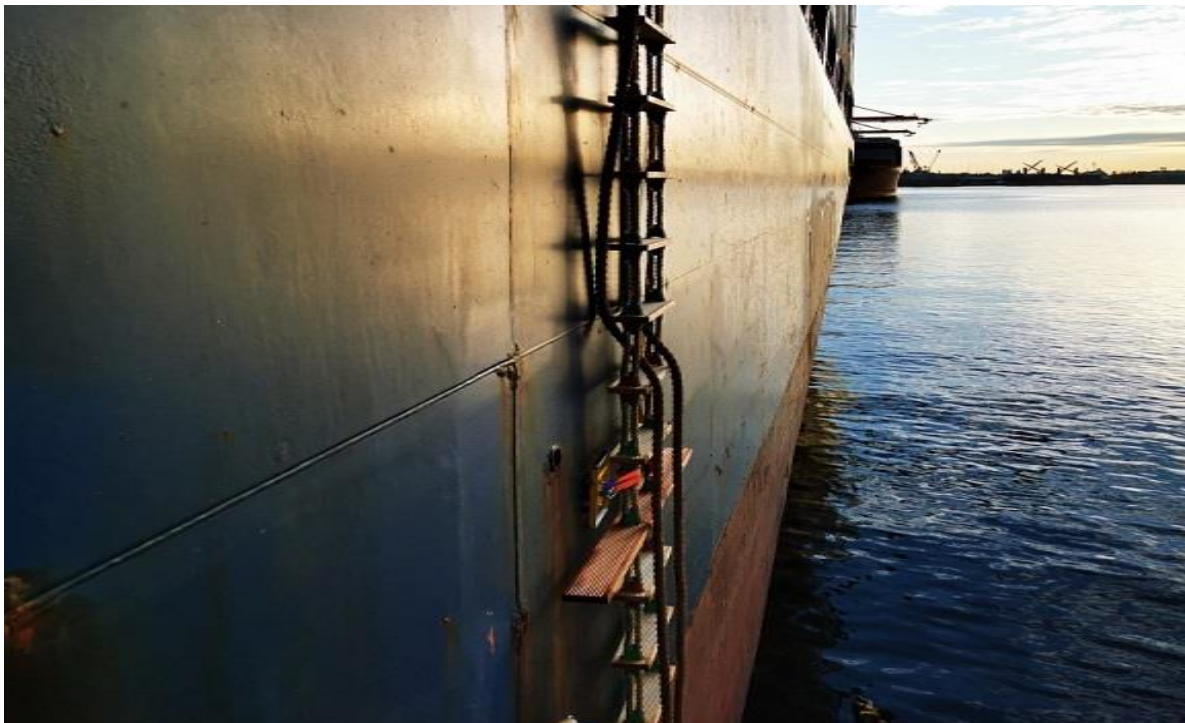
Each step of the pilot ladder **MUST** rest firmly against the ship's side. The pilot ladder **MUST** be secured to ship's side using eye pad or handhold or by a mechanical device such as magnetic clamps or a pneumatic suction pad.

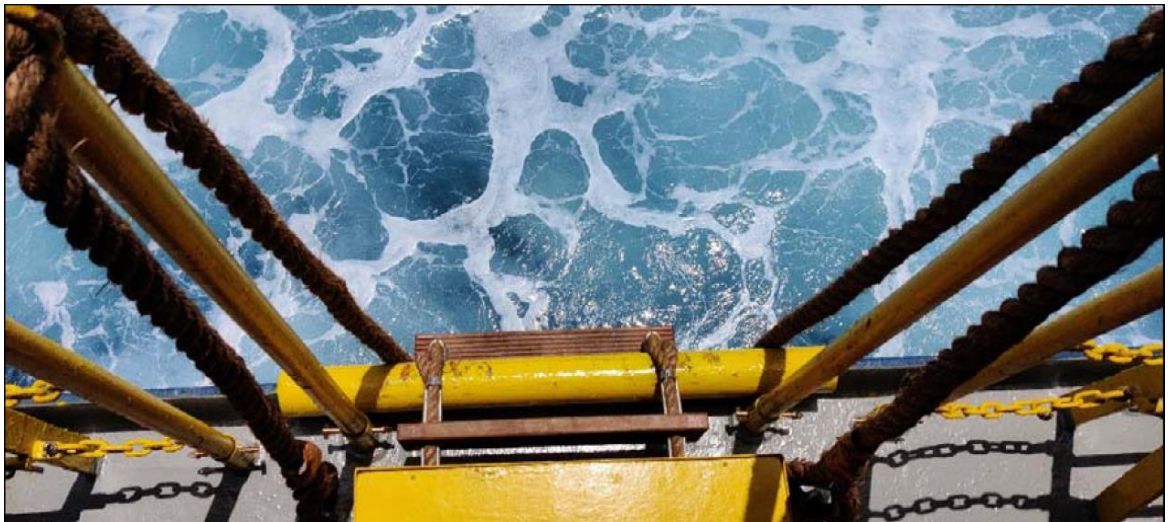
- **Two good manropes of not less than 28 mm and not more than 32 mm in diameter** shall be fixed at the rope end to the ring plate fixed on deck and shall be ready for use when the pilot disembarks, or upon request from a pilot approaching to board. Manropes shall be made of grade 1 manila rope.

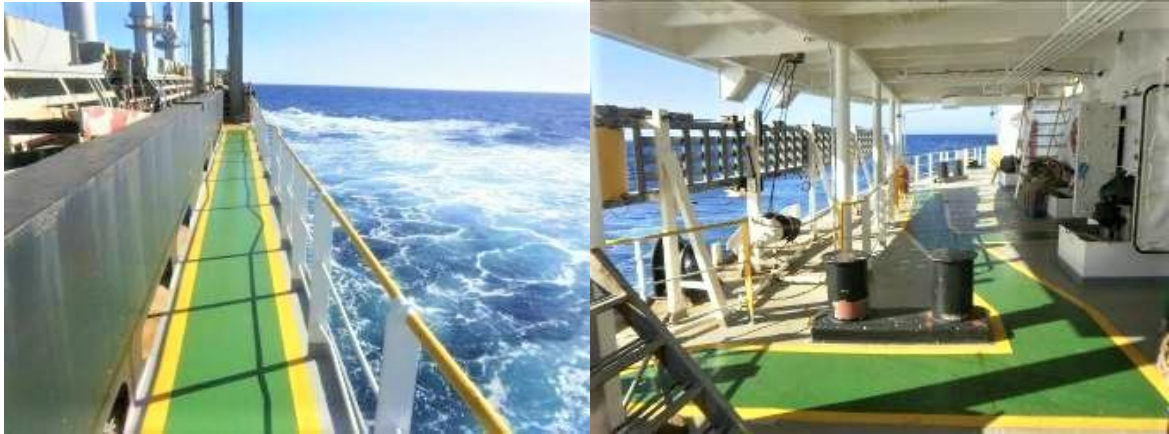
- **Safe, convenient, and unobstructed passage to be provided from the pilot boarding area to and from the vessel's navigation bridge**

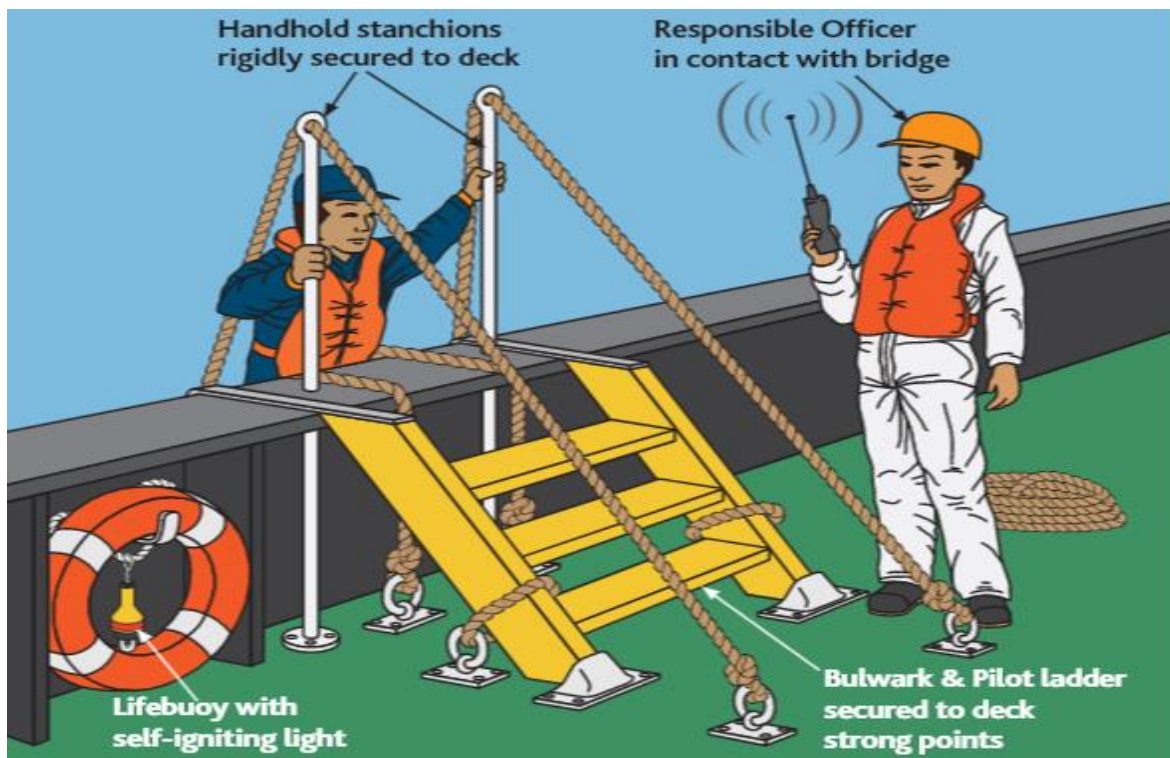
- **The rigging of the pilot transfer arrangements and the embarkation of a pilot MUST be supervised by a responsible officer having means of communication with the navigation bridge and who shall also arrange for the escort of the pilot by a safe route to and from the navigation bridge.**
