# Falsified Certificate for Pilot Ladders

**DMSG-10-15**

**Handling of  
Falsified DNV  
Certificates**

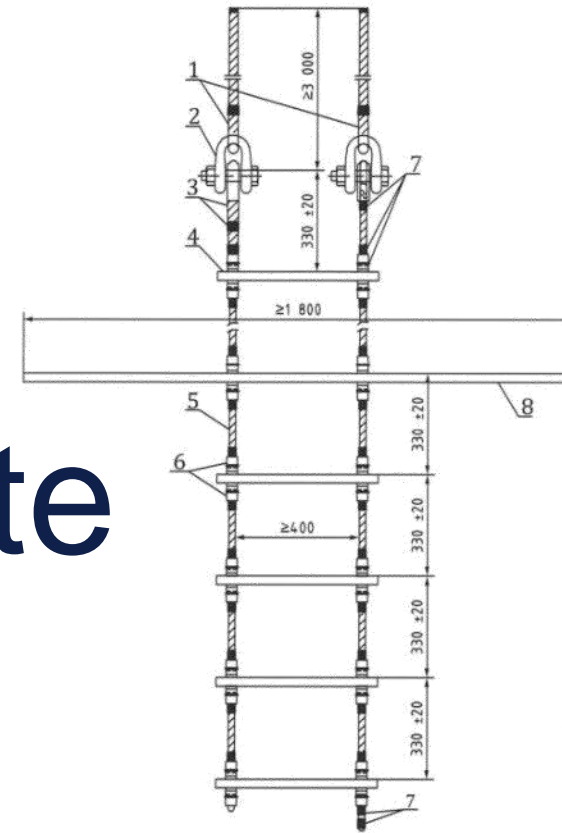
- |   |  |   |               |

| 1 | securing rope alternative arrangements | 5 | side rope |
| 2 | shackle | 6 | step fixture |
| 3 | splice and rope seizing | 7 | rope seizing |
| 4 | step | 8 | spreader step |

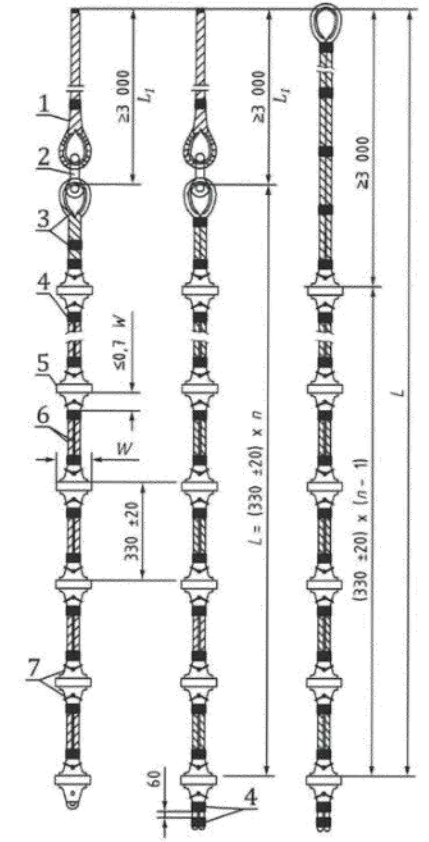
- |   |  |       |                               |

| 1 | securing rope alternative arrangements | 7 | step fixture |
| 2 | shackle | $L_1$ | length of securing rope |
| 3 | splice and rope seizing | $L$ | length of ladder |
| 4 | rope seizing | $W$ | width of the step |
| 5 | step | $n$ | number of steps in the ladder |
| 6 | side rope | | |
