# Inspection Results & Trends

**Relating to ARCSOPT Technical Guidelines**

ARCSOPT In Person Meeting – 01 November 2023

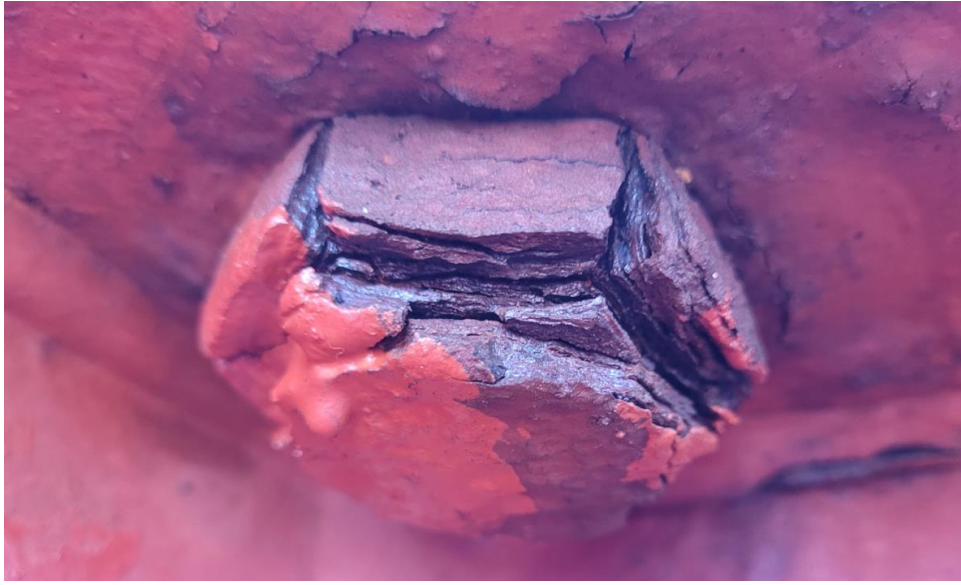
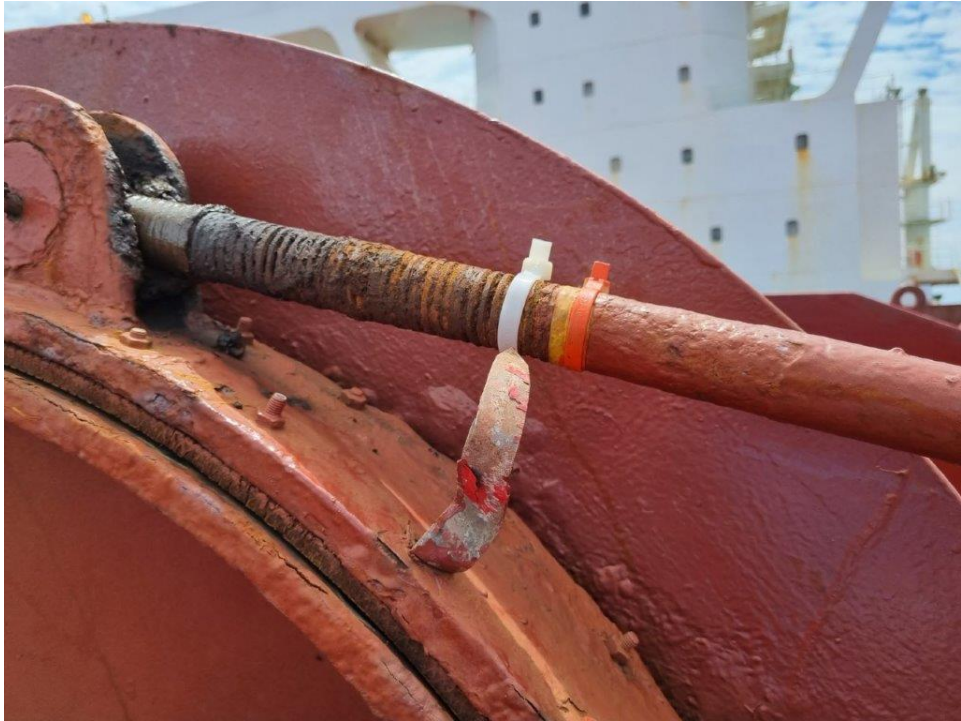
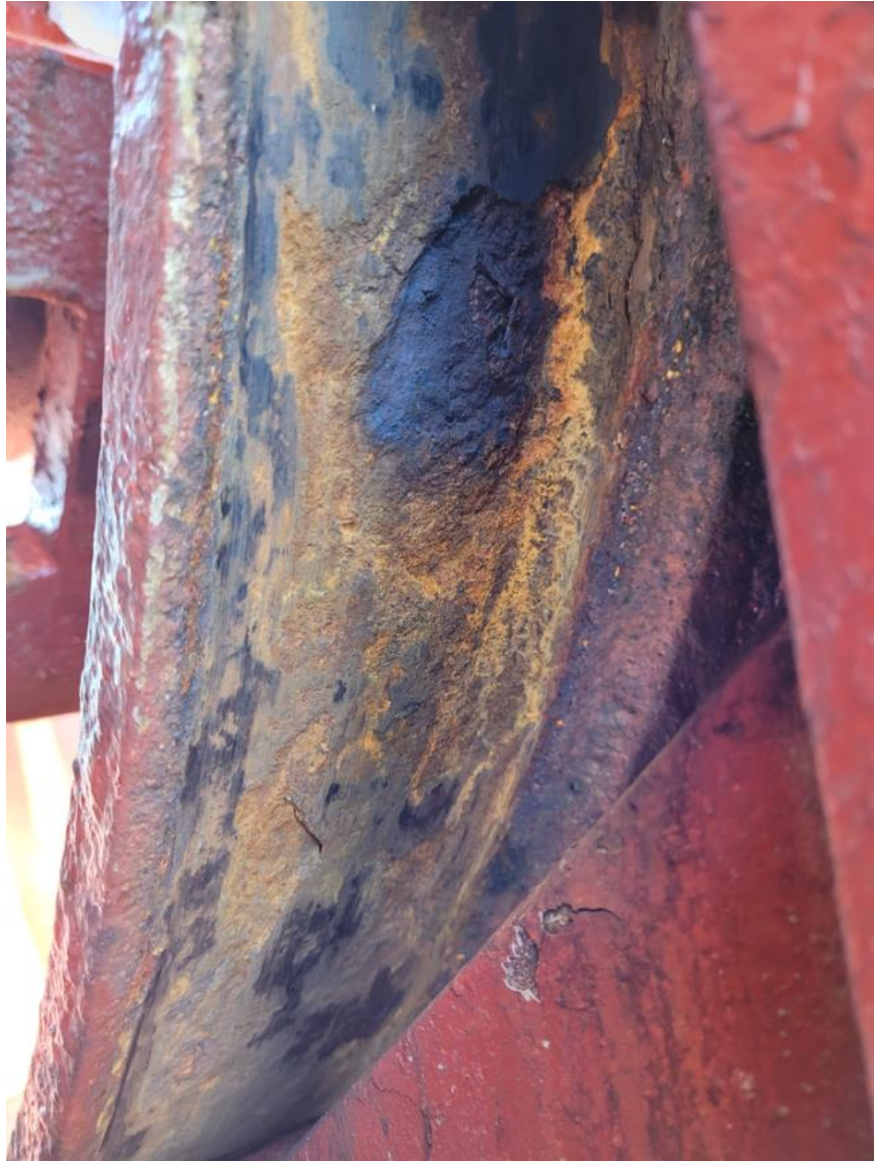
**1) Turn push buttons for both port and stbd anchor winches were heavily corroded and inoperable. Rectified during inspection by replacing them with new push buttons.**

**2) Limit switch cable lifters for both port and stbd anchor winches were damaged, not operational. (not rectified)**

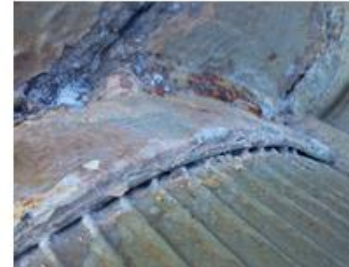
**stb pilot boarding gangway is suffering alloy cracks in handrails, steps and side fitting in way of rollers. cracks and splits also noted under hand rails or at hinge fixture.**
