RIGHTSHIP

- Safe Mooring Practices
- Marine Pilot Transfer Arrangements

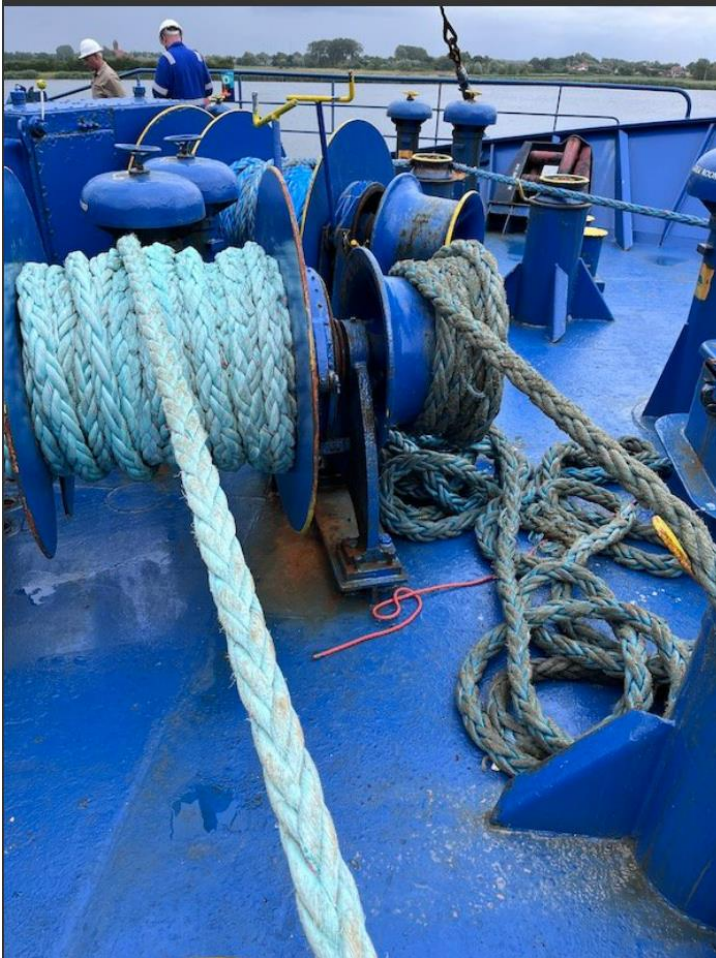
Lack of maintenance plan

Common findings are:

- Hydraulic oil leakage
- Condition of brake drums
- Brake band material worn down / thinned
