CRANE WIRE FAILURE AND AFTERMATH

01 February 2023

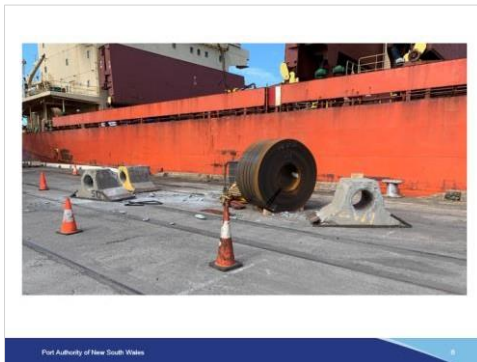
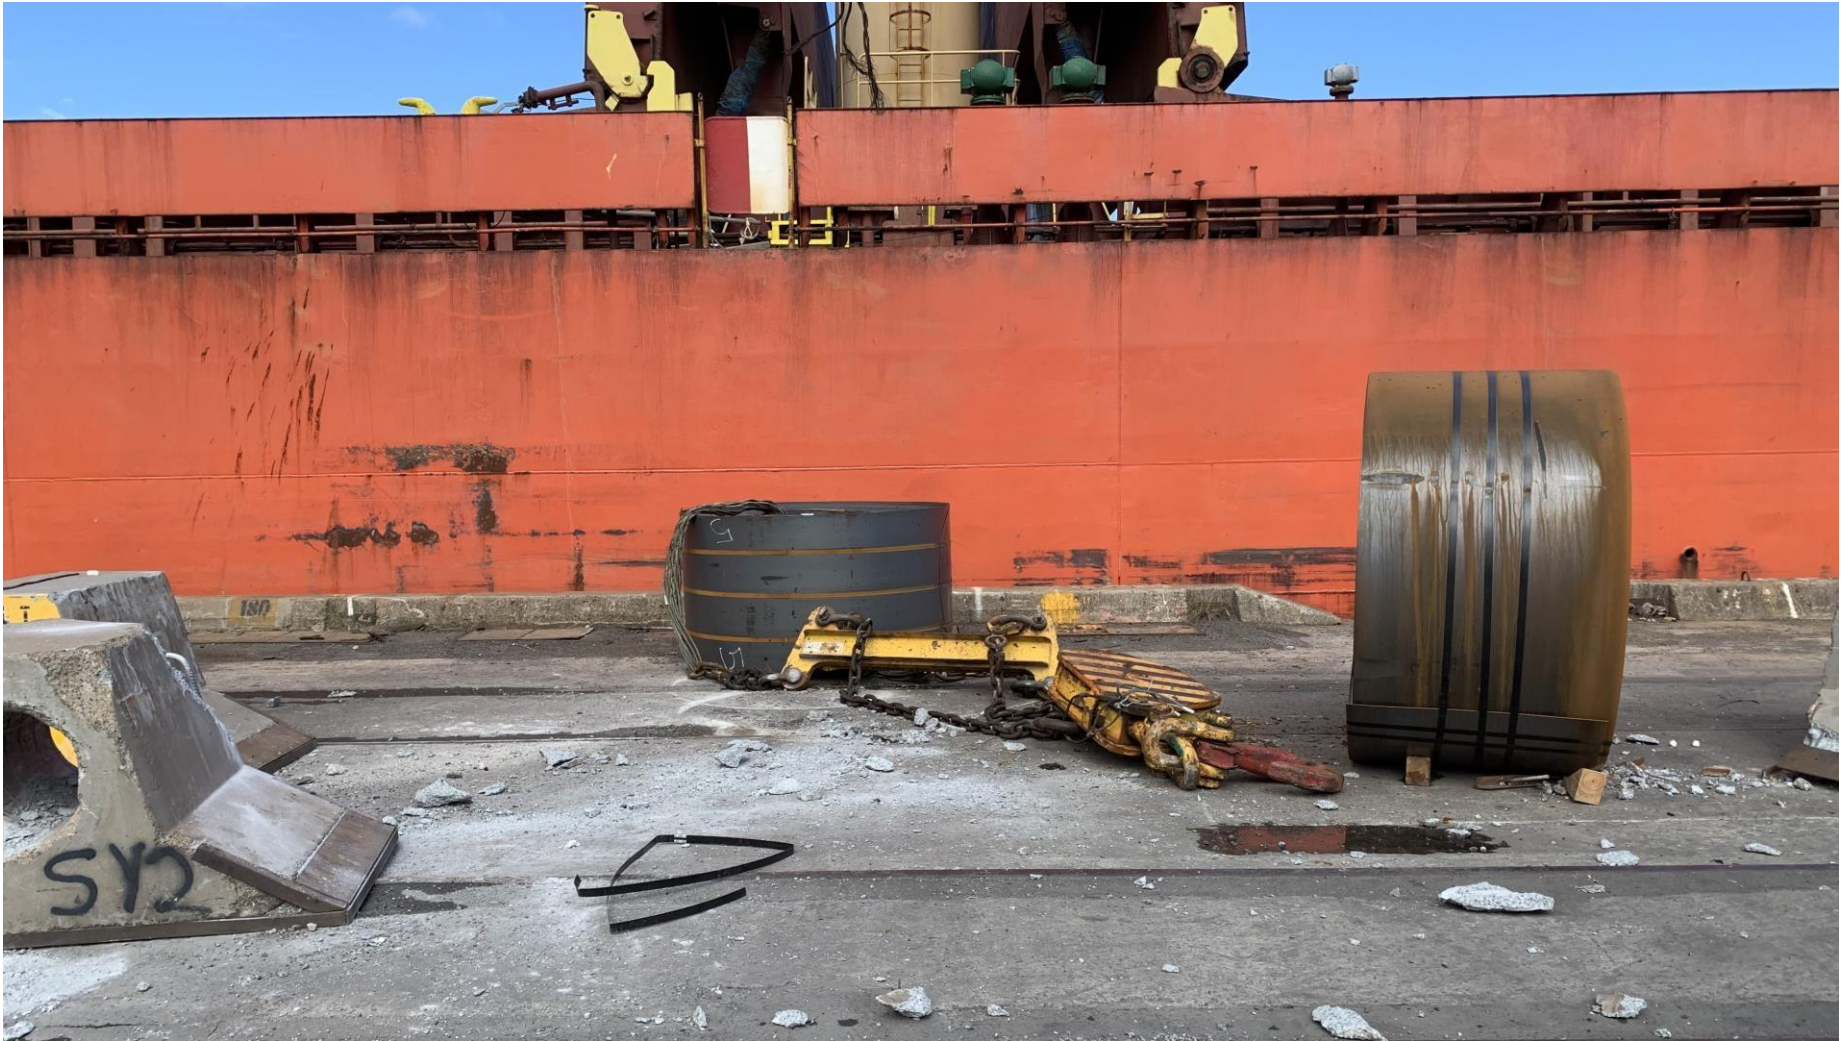
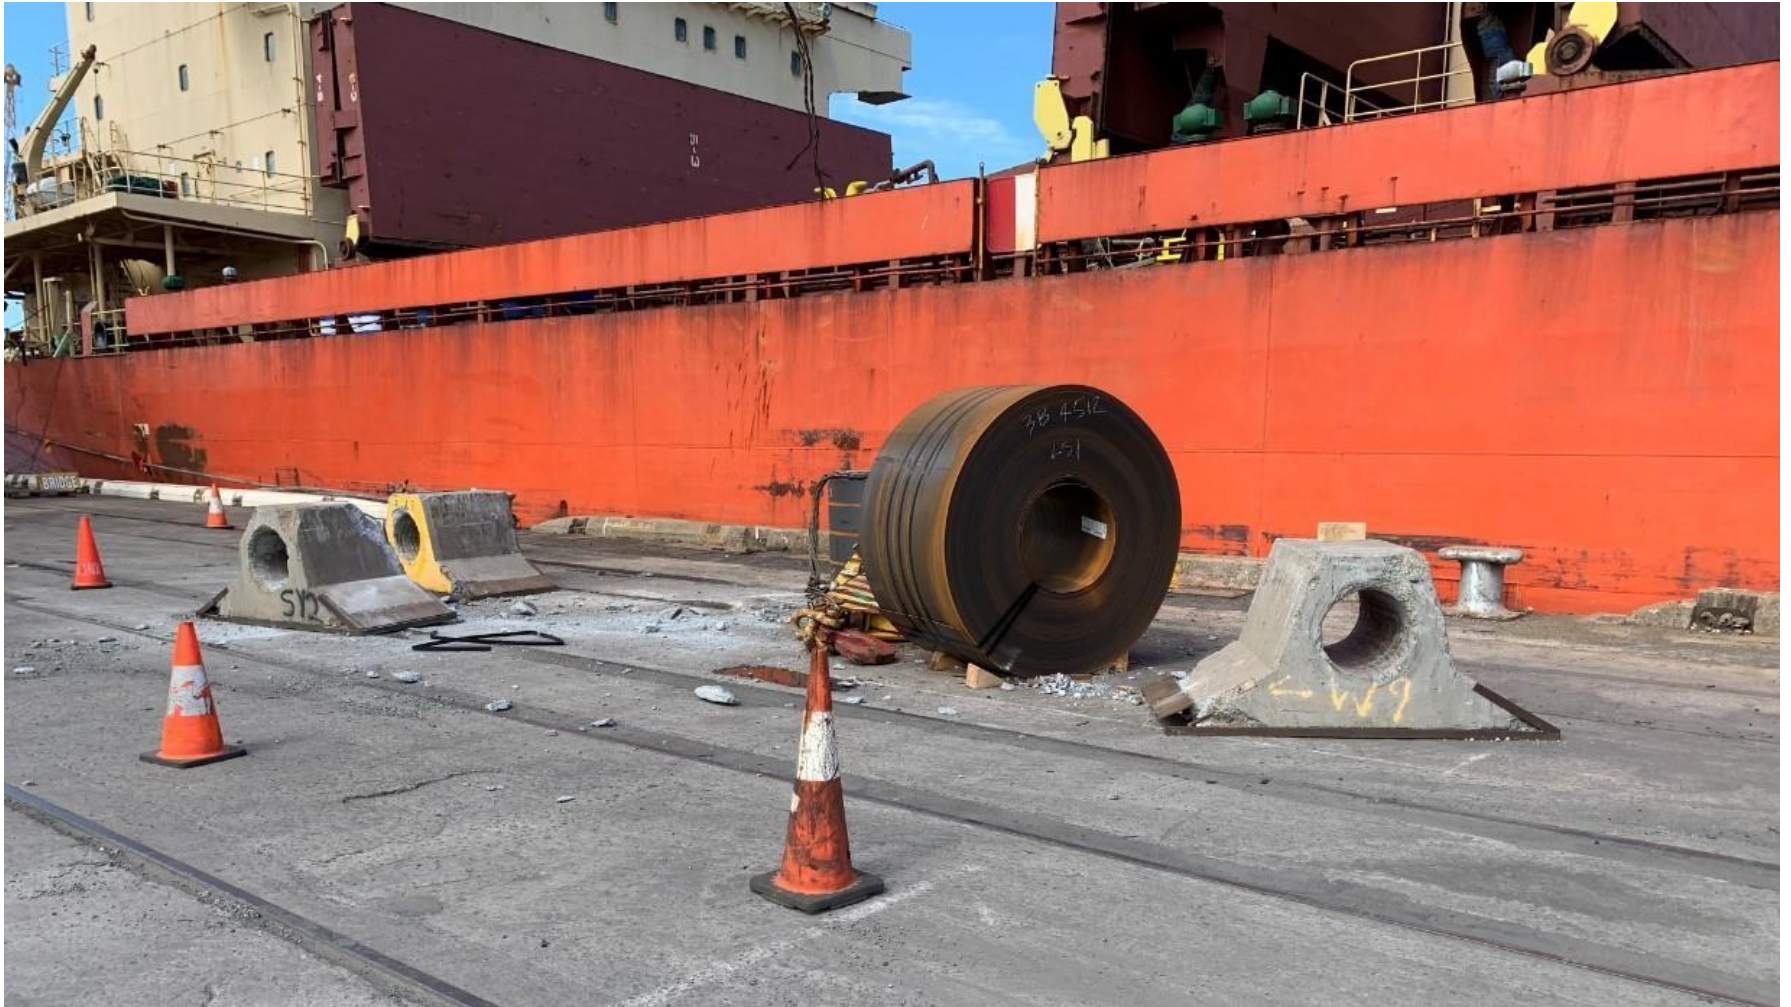
The coil on the left was the one being lifted

It dropped onto the coil on the right, spinning it around approx. 90deg and pushing the concrete barrier away from beside it

The coil that fell then hit the barrier that was between the coils and pushed it out in the other direction, with the coil that fell landing on its face on the berth

Exclusion zone for personnel meant that no-one was injured

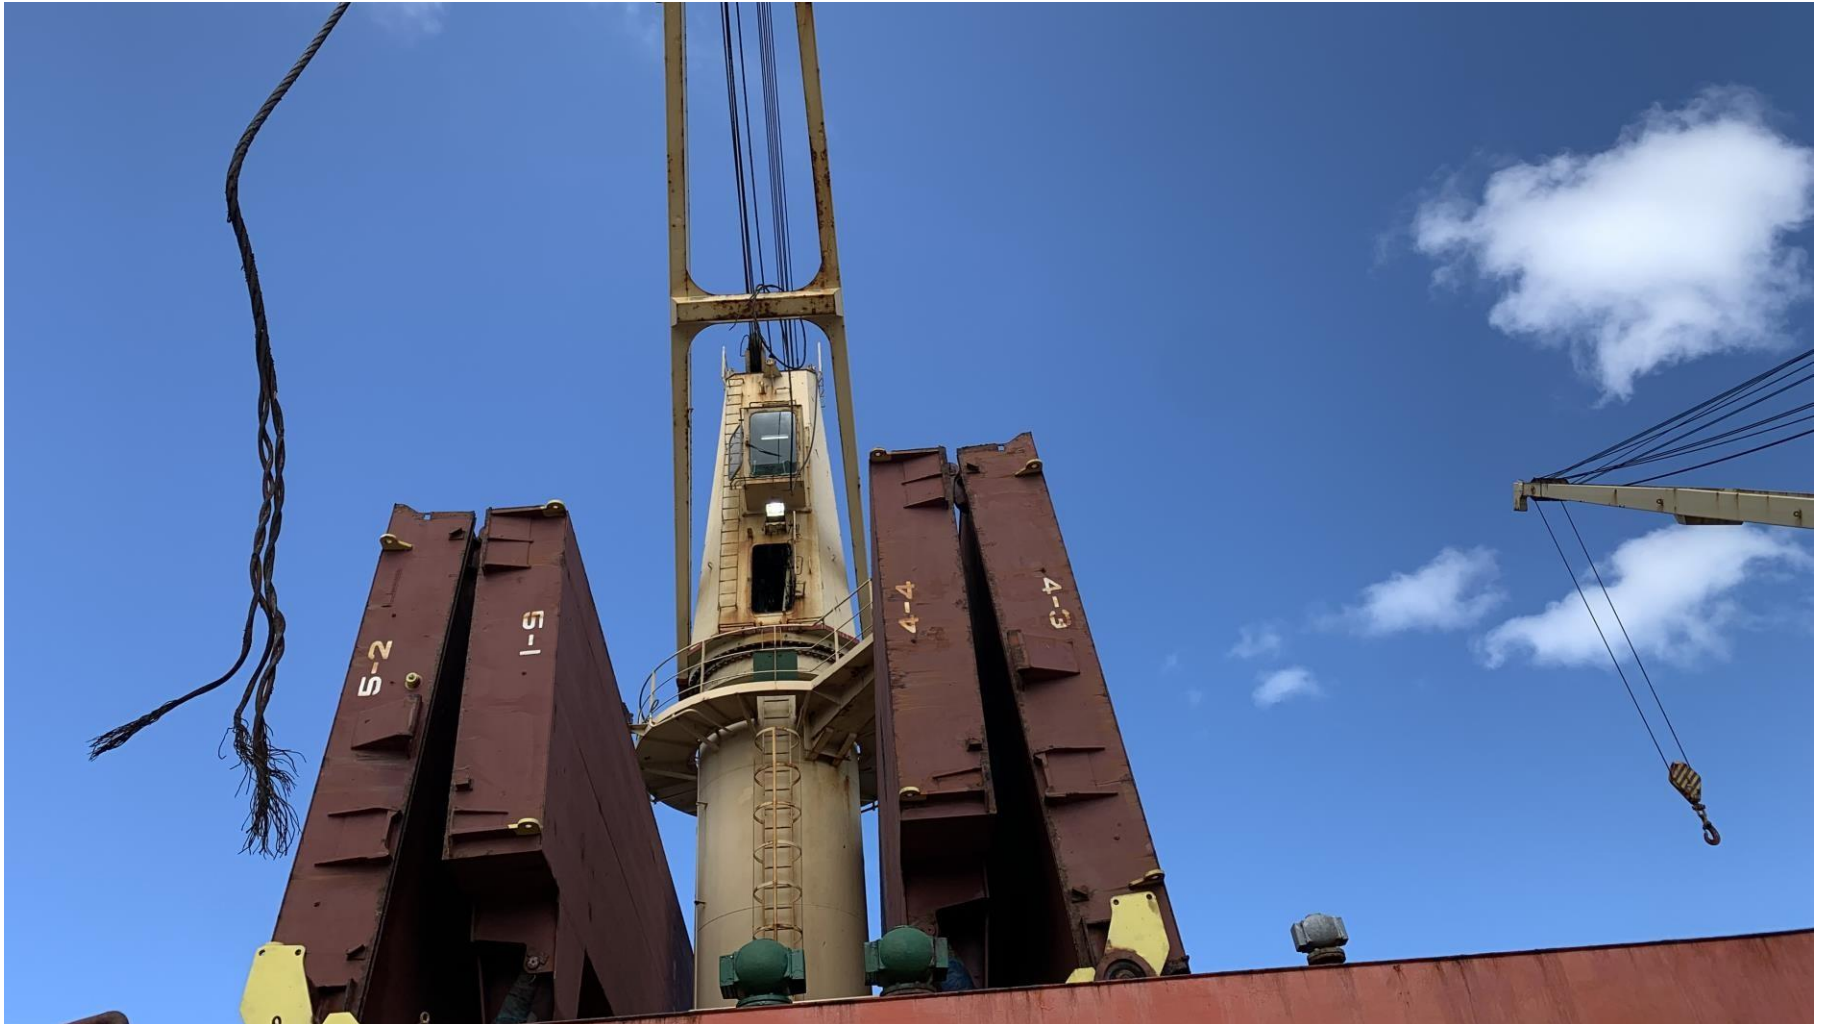
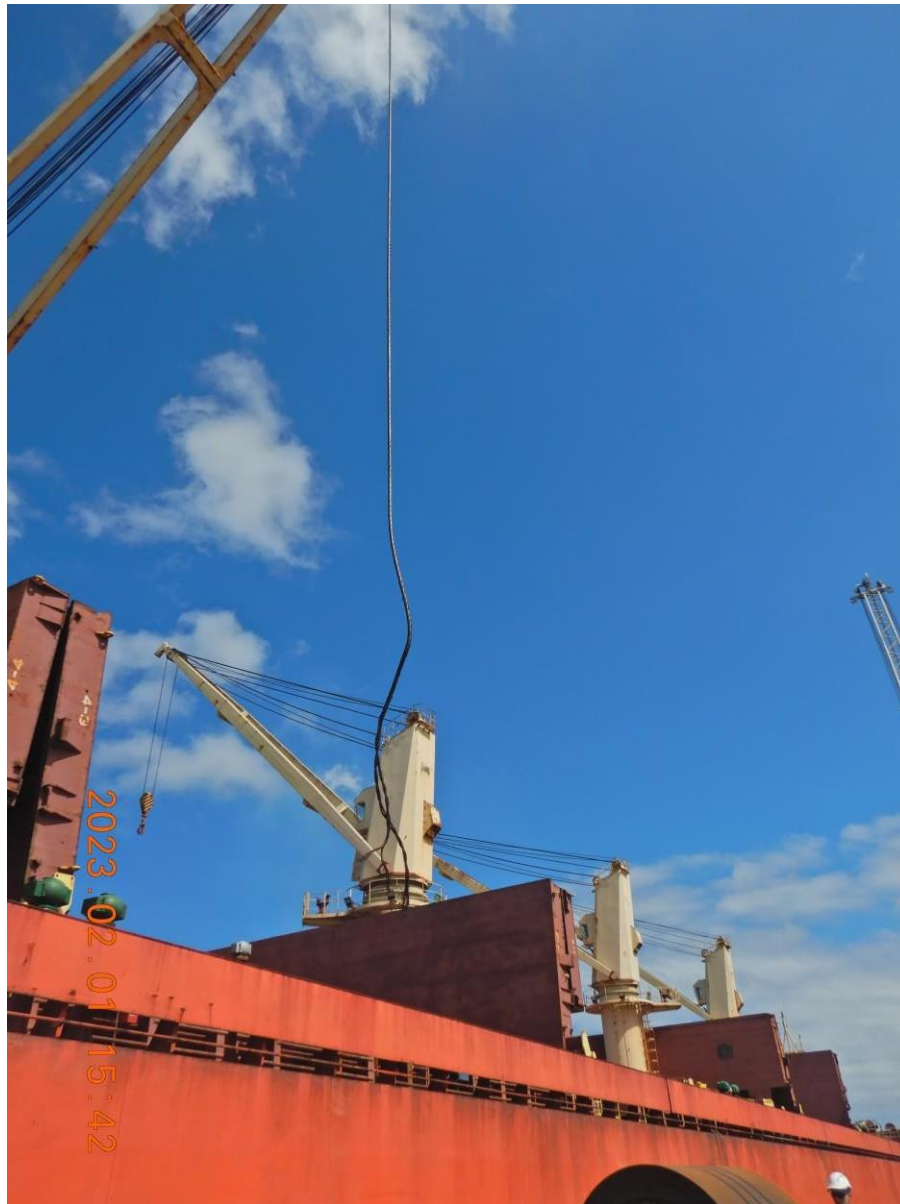
Root Cause Determined by Stevedores

Post incident visual inspection of the broken crane wire strands is indicative of internal corrosion of the crane lifting wire

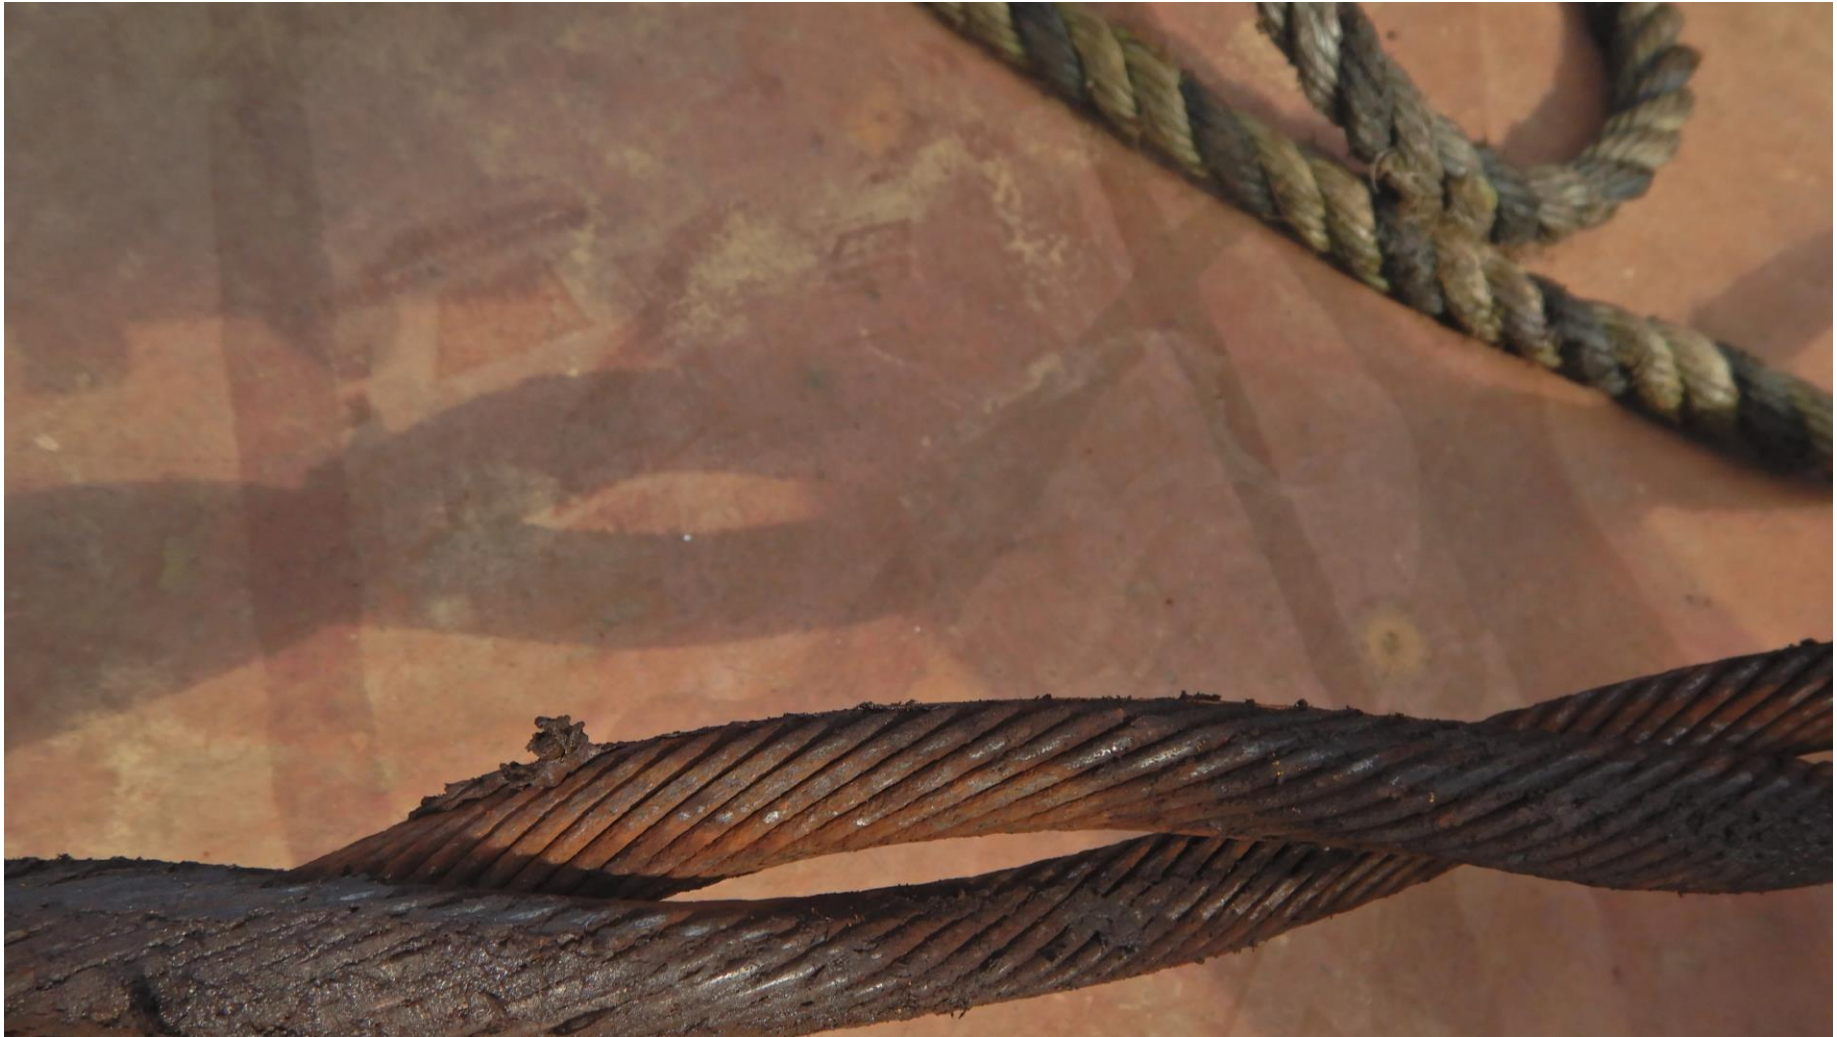
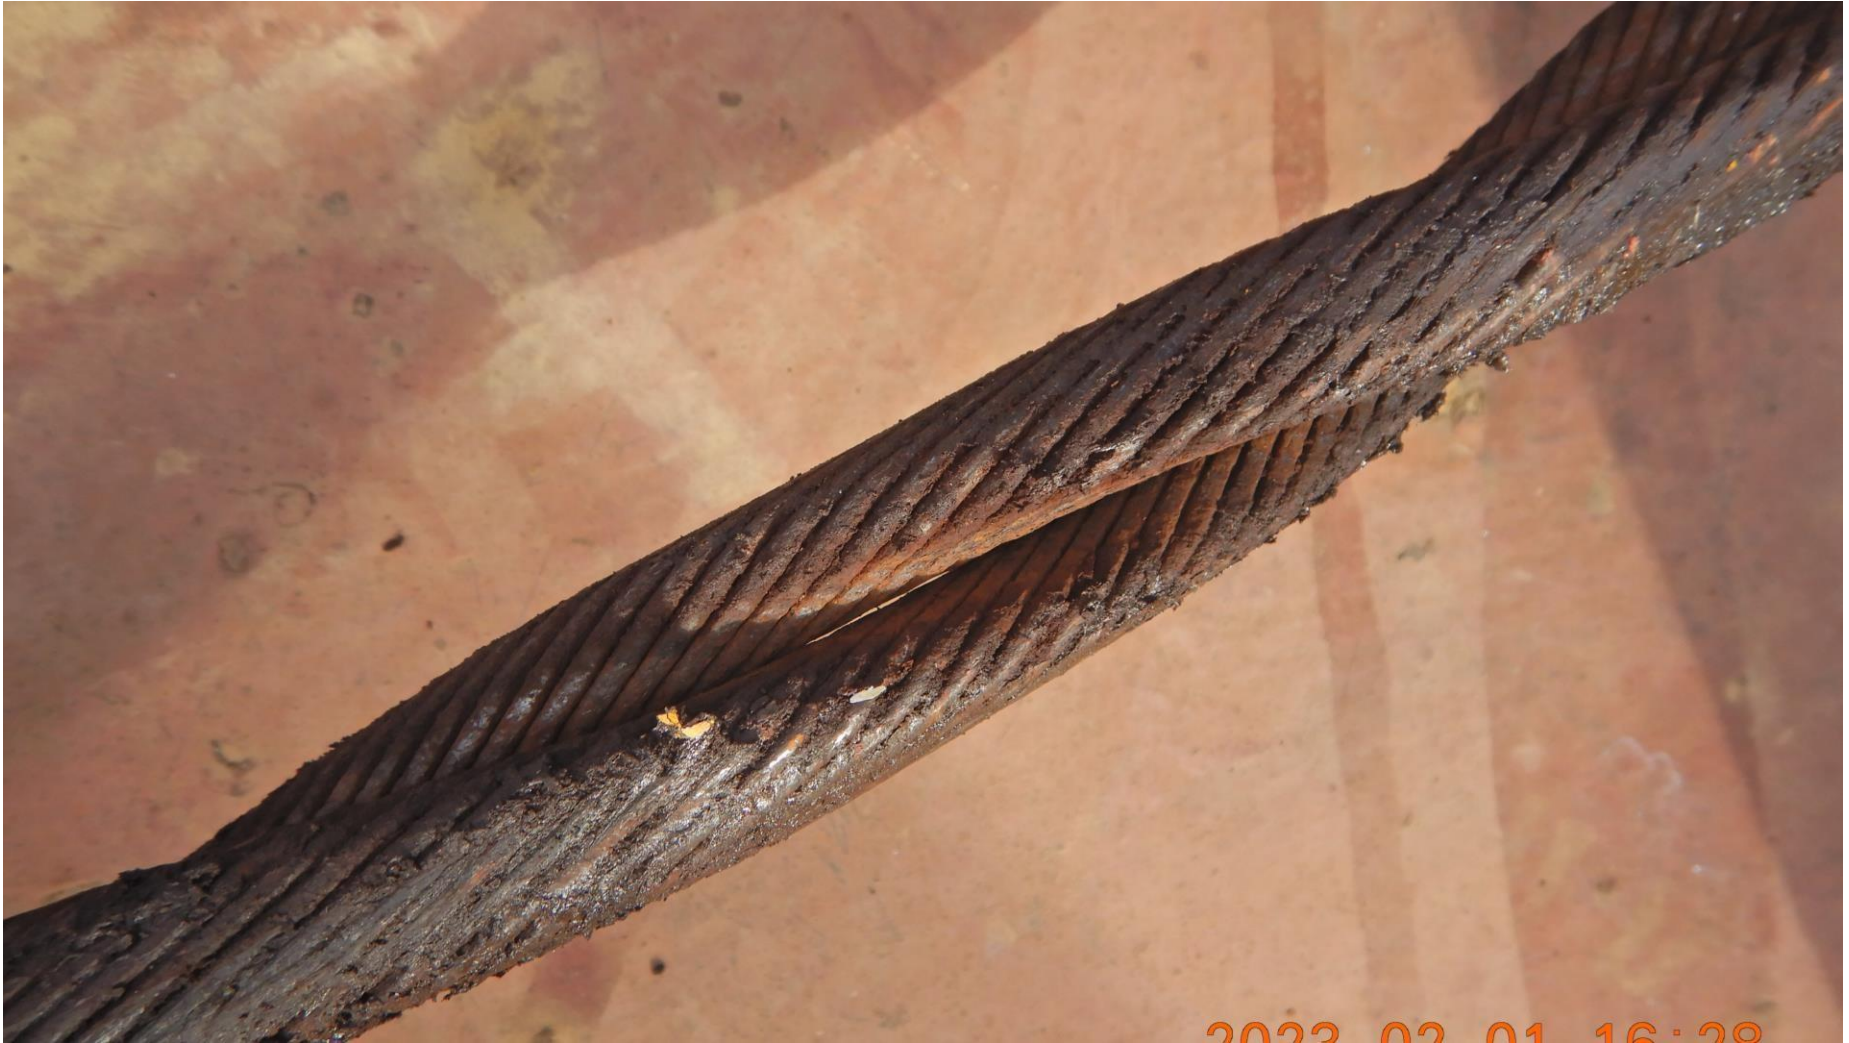
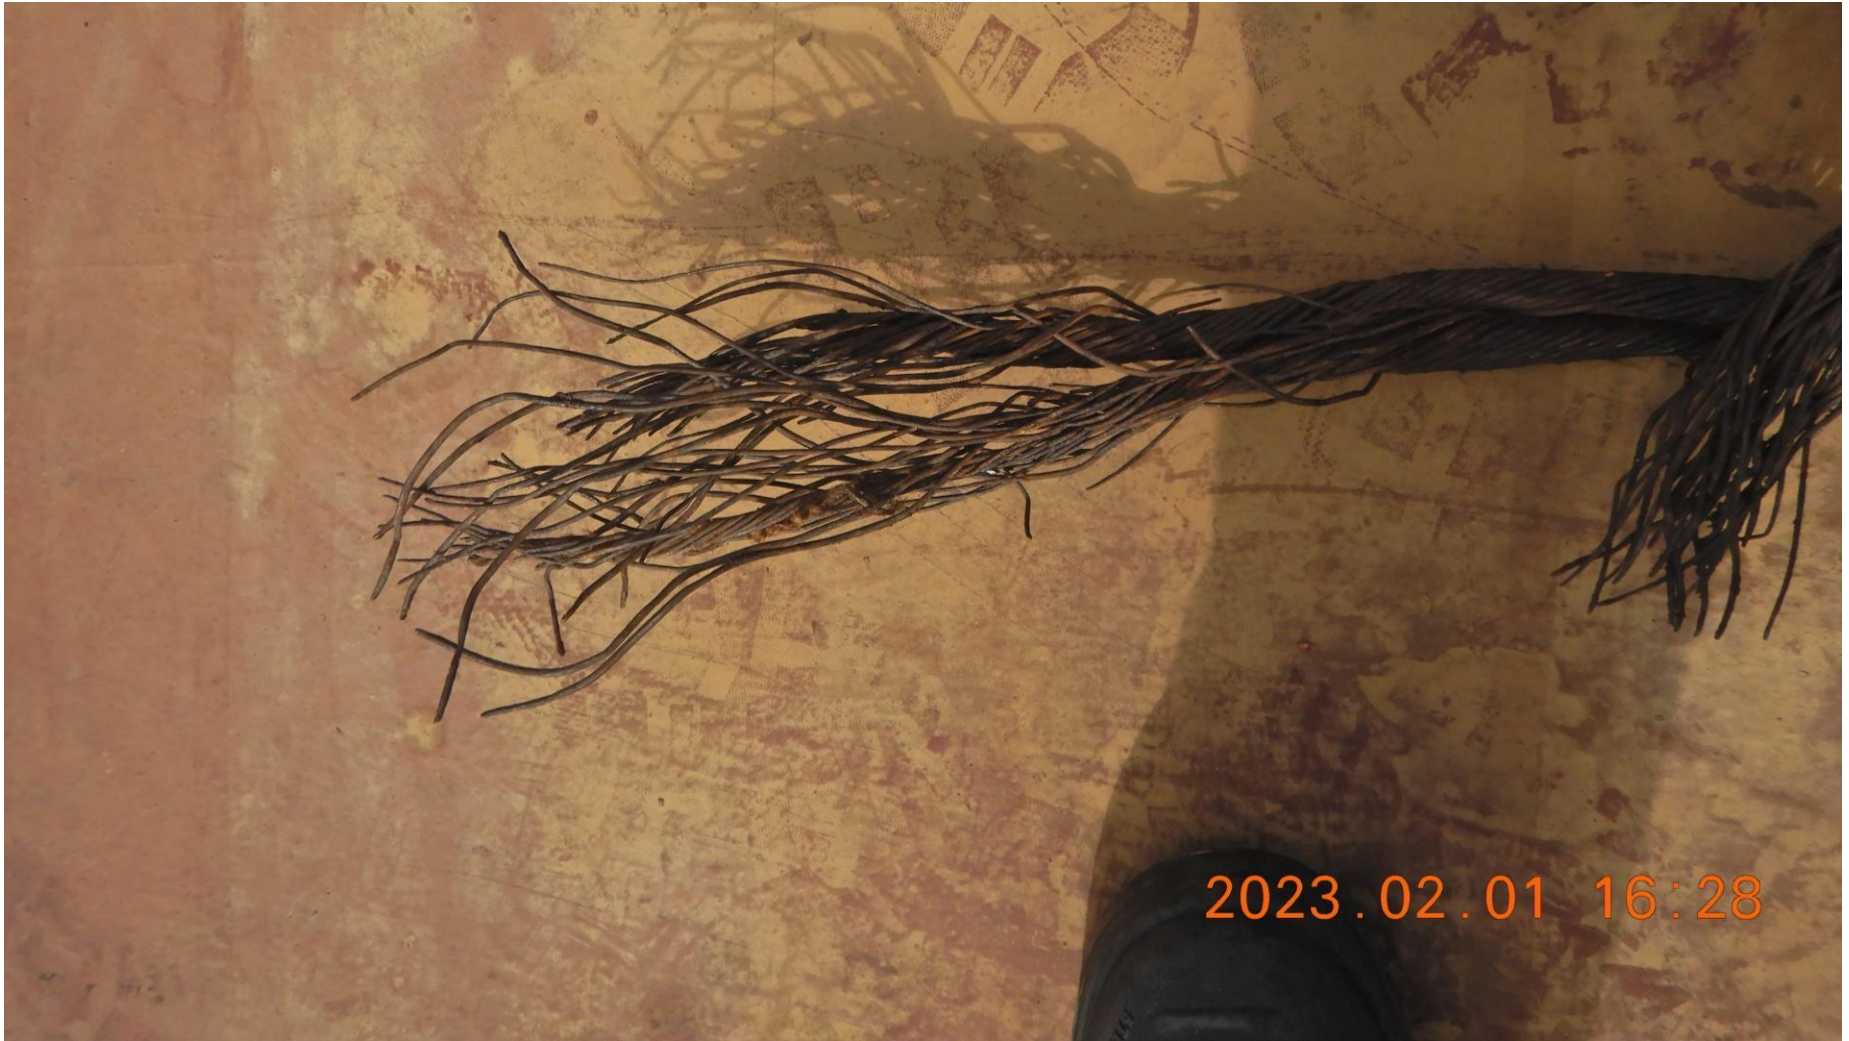
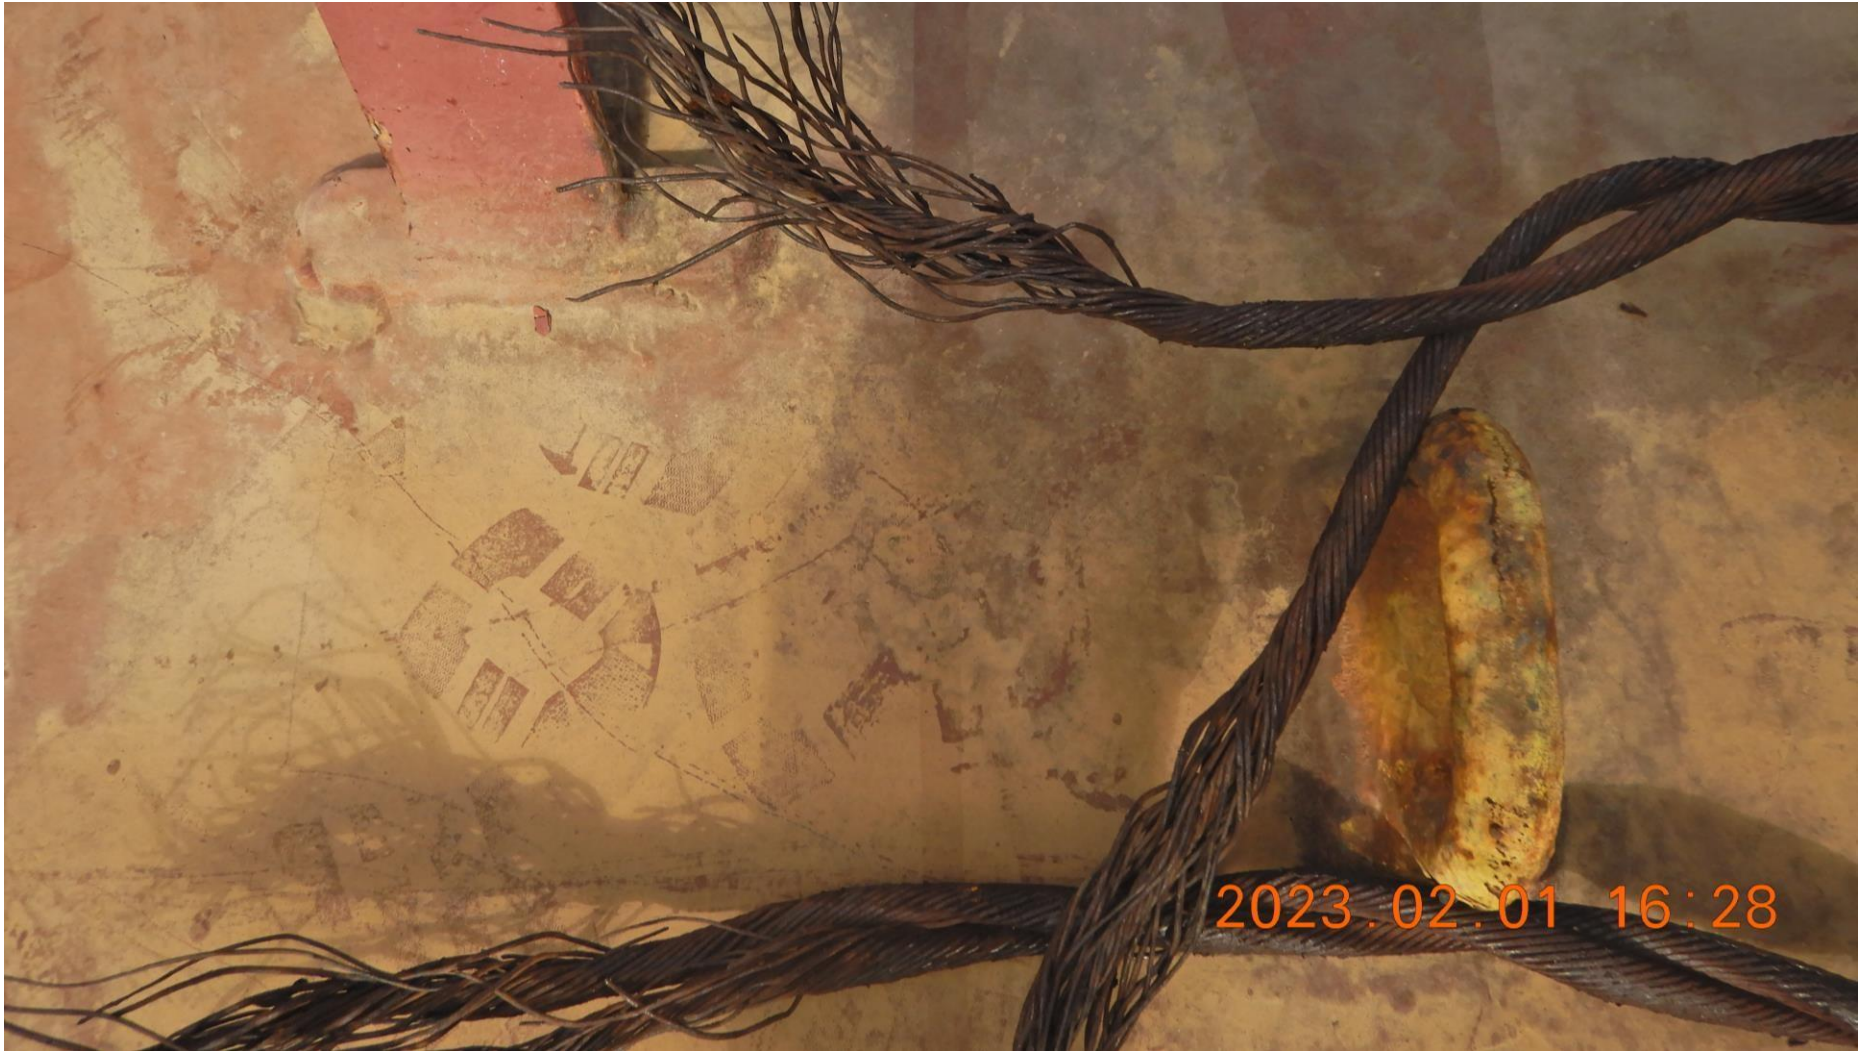
03 Feb 2023 examination of parted wire – internals/ core dry and or corroded

Surface lubricant on wires was plentifully applied, at a minimum

Wire's core appeared dry and surface corrosion commonplace
