# FREMANTLE PORTS

Incident and Process improvement

# **Serious Marine Incident - Marine Pilot Transfer**

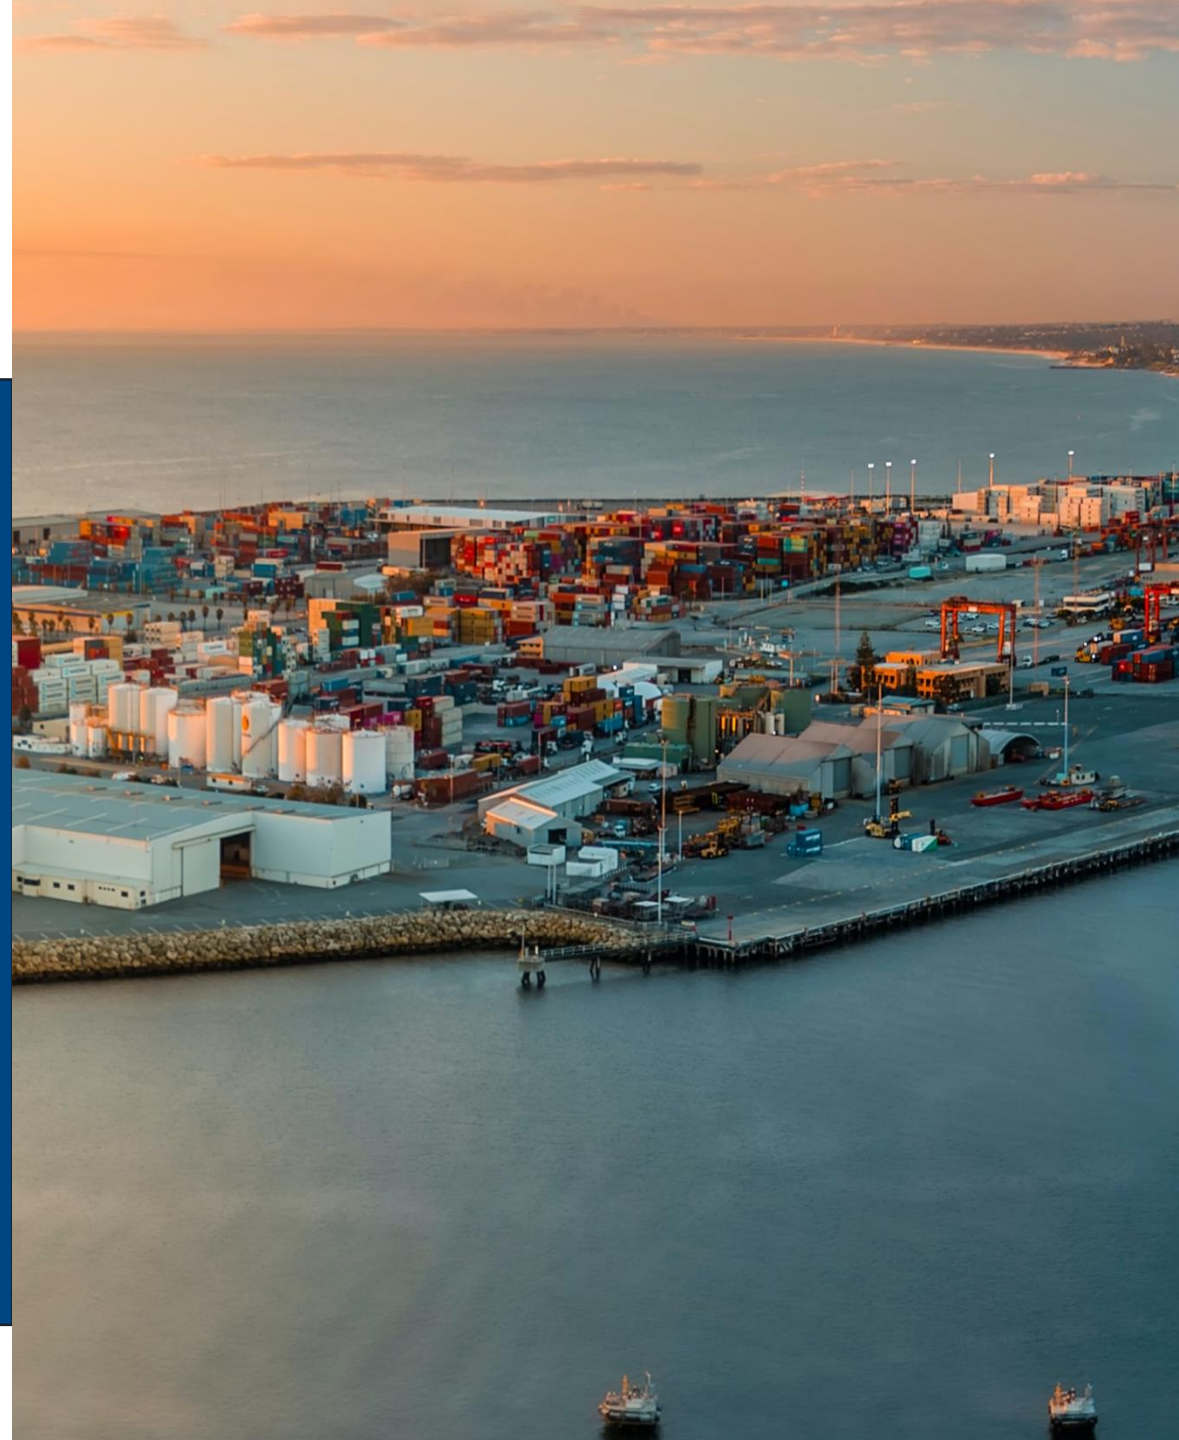
- Pilot ladders more than 4 years old and in poor conditions
- Poor storage locations used for Marine Pilot Transfer equipment
- Safety Management Systems
- Fraudulent Classification Society certificates provided by suppliers to ships
- Unsafe trap door arrangements
- Unsafe methods used for rigging and securing of pilot ladders
- Manropes not complying with the size requirements (28mm - 32mm)
- Non-compliance with SOLAS Chapter V Reg 23, IMO Res. A.1045(27), ISO 799-1:2019 and supplementary standards (ISO 799-2:2021 and ISO 799-3:2022)
- Manropes did not have applicable test certificates

- Enhanced surveillance from Fremantle Ports (pre-arrival), pilots, pilot boat crew. Identification of sub-standard arrangements and vessels
- Engagement with Classification Societies for certificate verification - collaboration
- Engagement with local independent operators for ship inspections
- Communication with other Australian Ports - Harbour Masters'
