Fatality due to Electrocution

The Case

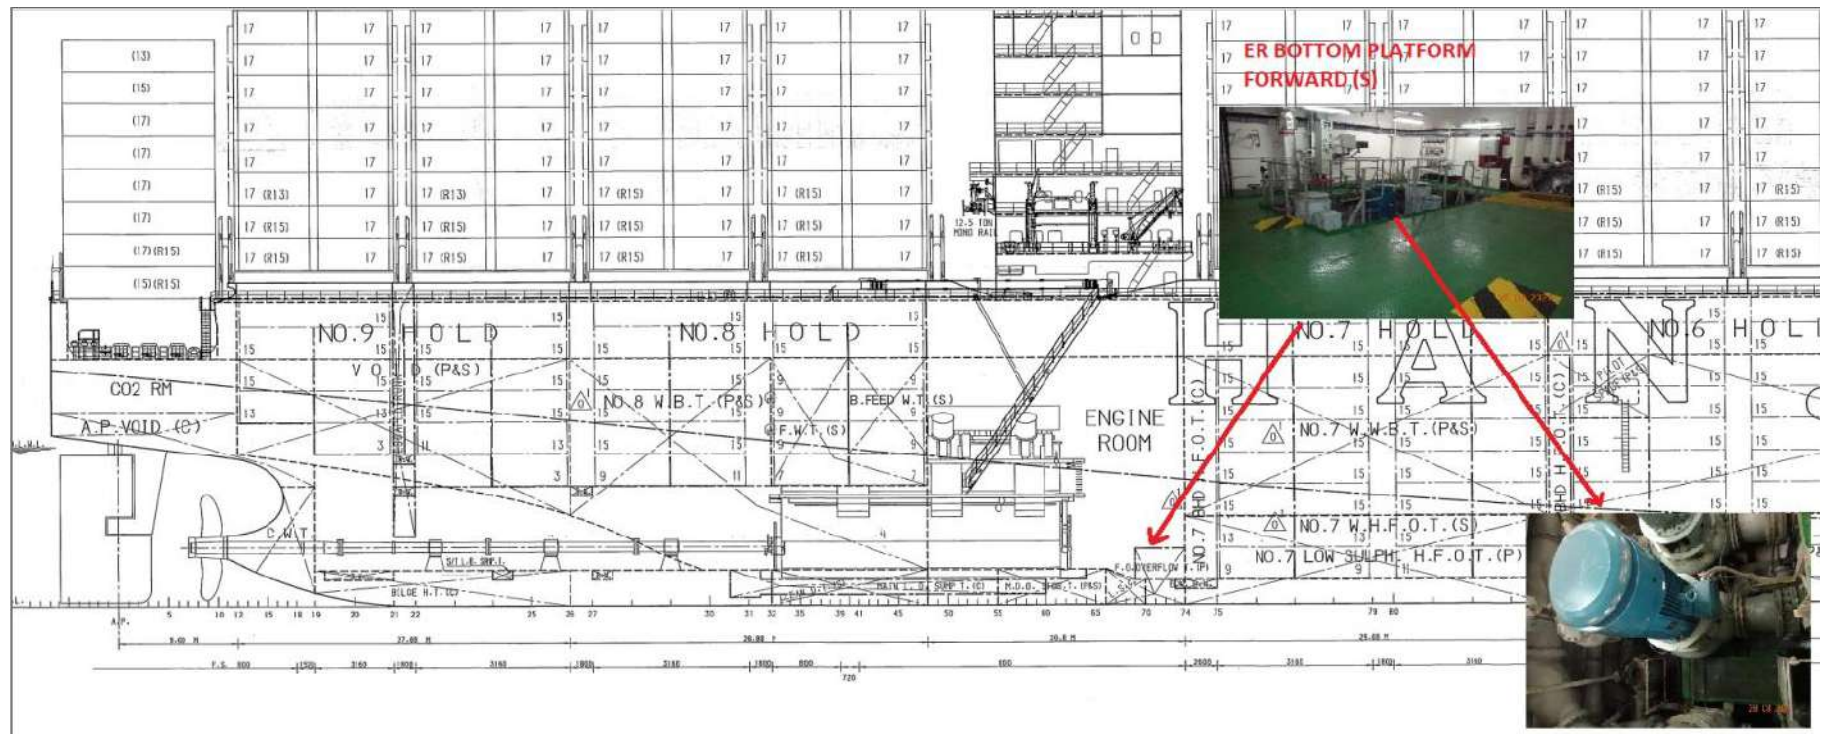
Vessel was en route from Jeddah to Tangier after crossing Suez Canal, northbound. During the reconnection work of electrical cables on the Main Cooling Sea Water Pump No. 2, Electrical Officer sustained electrical shock. He was administered CPR, and later air evacuated with assistance from Hellenic Coast Guard, Greece. He was declared dead on arrival at Heraklion hospital.
